Cougar Creek/Northeast Interceptor Canal INTEGRATED STORMWATER MANAGEMENT PLAN FINAL REPORT

JUNE 2009

Submitted by:
Dillon Consulting Limited
130 – 10691 Shellbridge Way
Richmond, BC V6X 2W8

Project Nos.: 06-6904 and 06-6987

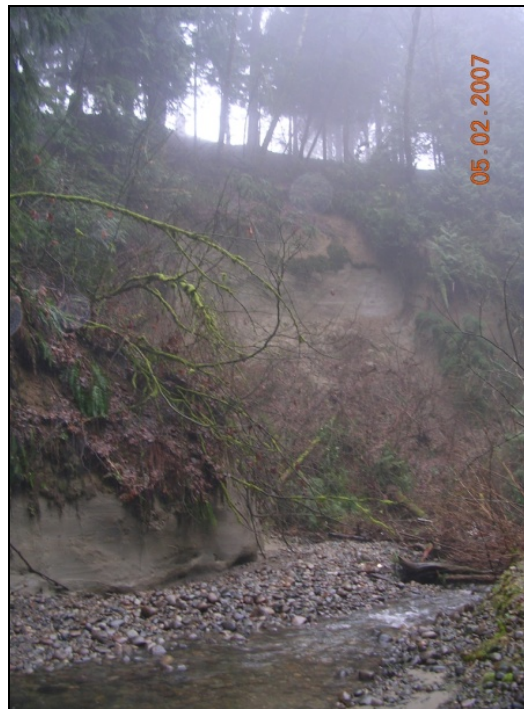
Photo 1: Large Slope Erosion with Houses near Slope Crest, an Example of Undercutting and Slab Regression.

2. Undercutting and Slab Regression: This type of mass movement results from erosion at the toe of the slope and resulting failure of the oversteepened slope. Such undercutting and failure of the slope in dense sand, and sand and gravel results in small slab failures regressing up the slope at very steep slope angles. After the stream moves away from the toe of the slope, the slope ravel to a long term stable slope angle. It is often during this phase that the movement reaches the crest of the slope. There are several of these features where Cougar Creek cuts down through the erodable material, all on the left bank, between the pedestrian overpass and the elementary school at Lyon Road. This is the most common active bank feature in the valley and is a major source of sediment load for the stream.

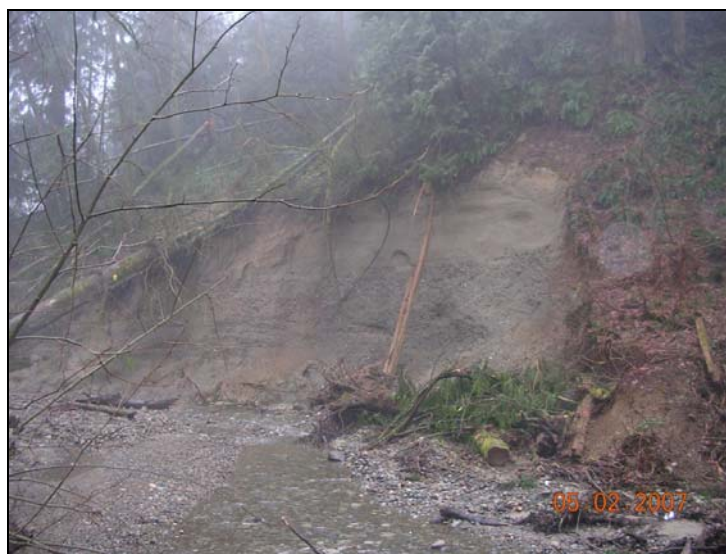
Photo 2: The Largest Eroded Slope in Cougar Canyon, an Example of Undercutting and Slab Regression

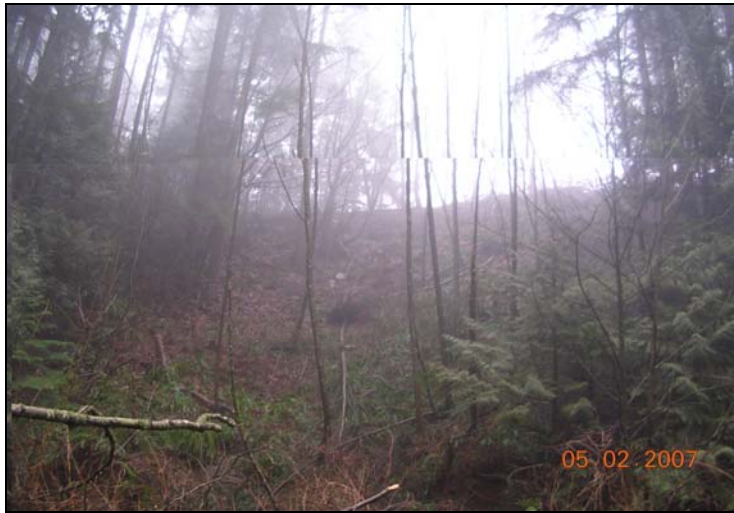
Photo 3: Probable Area of Fill Placement on North Bank

Some fills were noted in both Surrey and Delta, but in areas where the Canyon was relatively shallow. In these areas, the greatest threat is temporary stream blockage as a result of fill failure. Little risk to structures is anticipated. The presence of fill at slope crests was not investigated during the field traverse in the deeper sections of the Canyon due to both time constraints and property access rights. It is probable that several lots will have fills, as that would have been a normal practise.

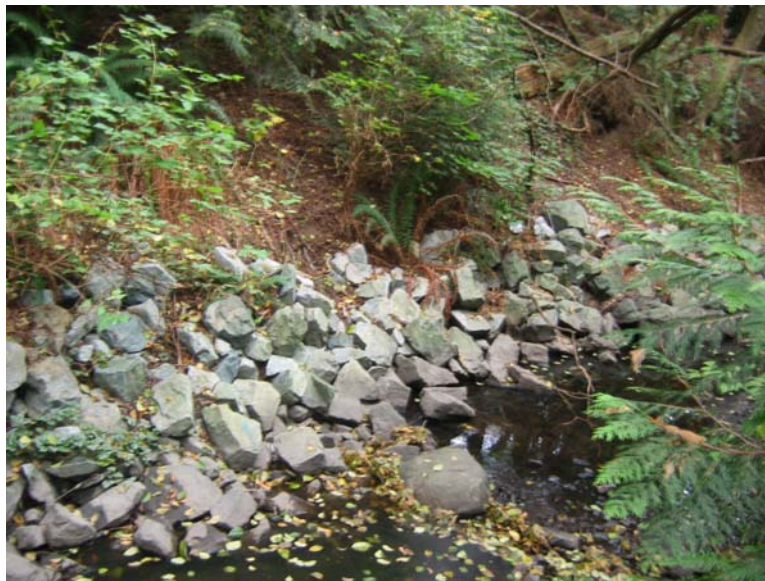
Photo 4: Example of Area of Terrace Instability with Stabilization Works

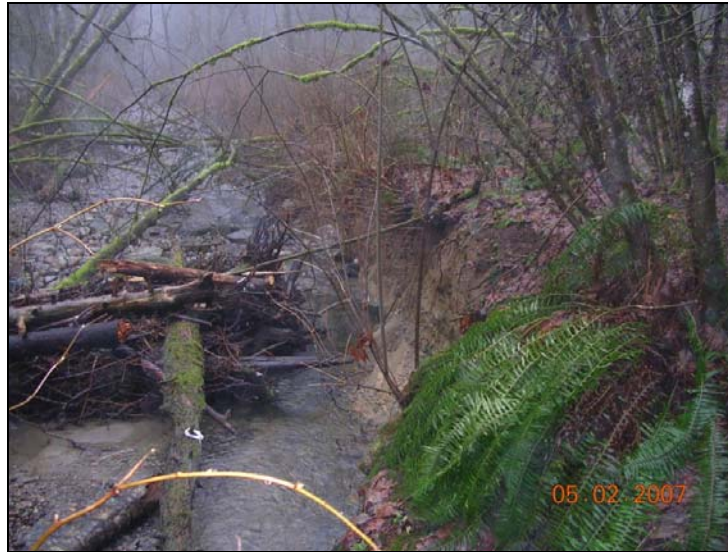
Photo 5: Erosion into Terrace on Right Bank

6. **Bank and Bed Erosion:** At several sites downstream of Nicholson Road, Cougar Creek appears to be slowly downcutting. The erosion activity may be related to climate and/or development that increases peak stream flows. This activity generally contributes sediment to the stream bed. In addition, related stream bank erosion provides additional sediment source. Where stream bank erosion impacts Canyon slopes, slope instabilities as noted in point 3, above is observed.

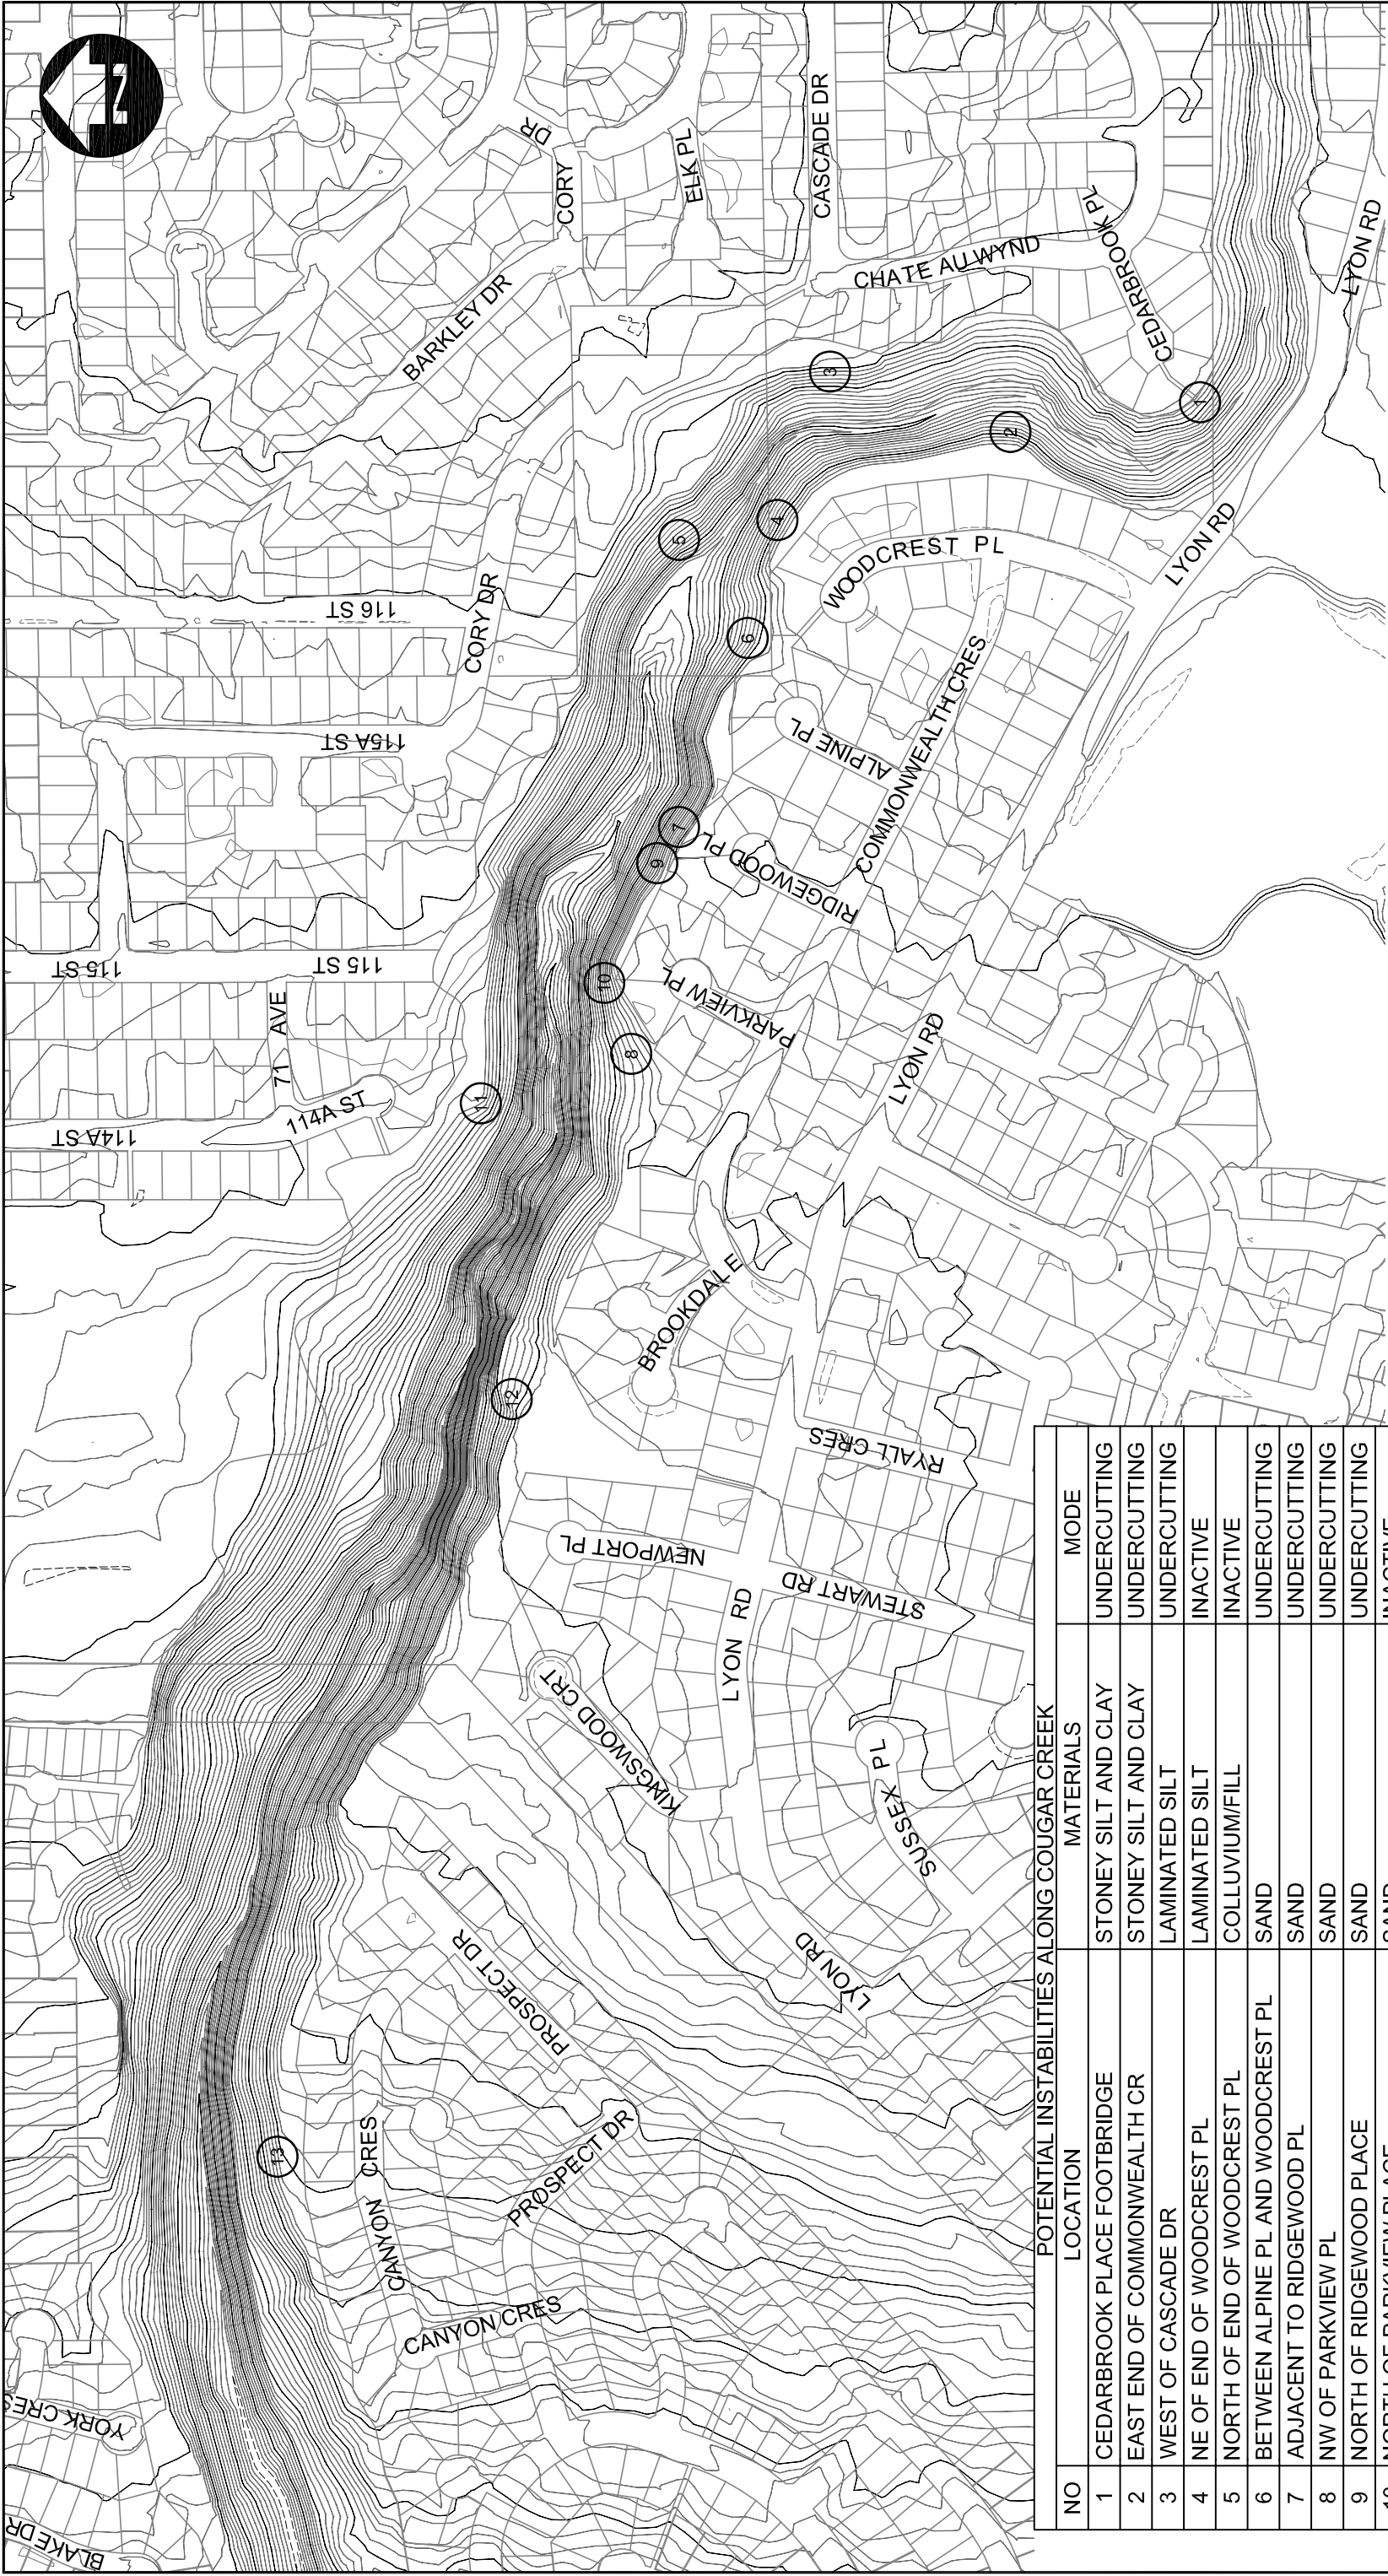
POTENTIAL INSTABILITIES ALONG COUGAR CREEK

Number 5 is on a slope composed of very loose material, probably fill. Older trees common in the valley are missing on this slope. There are no dwellings near the crest of this slope.

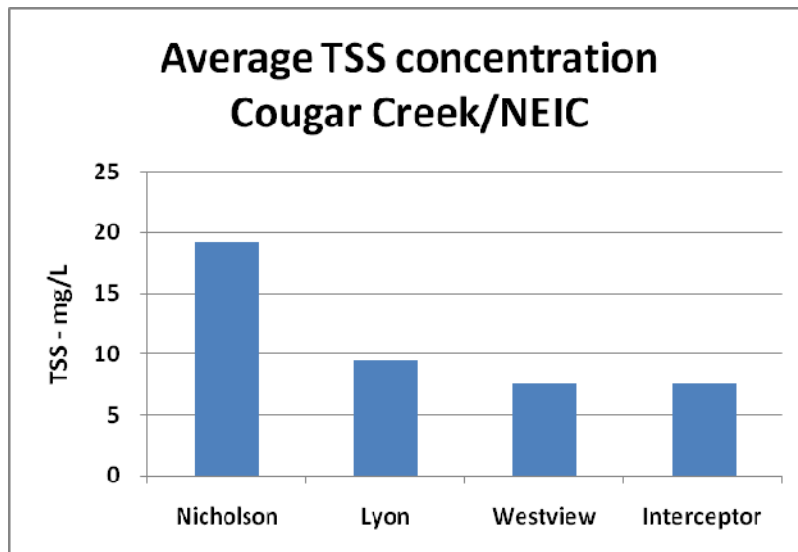
Figure 2-10: Average TSS Concentrations at Four Sample Sites

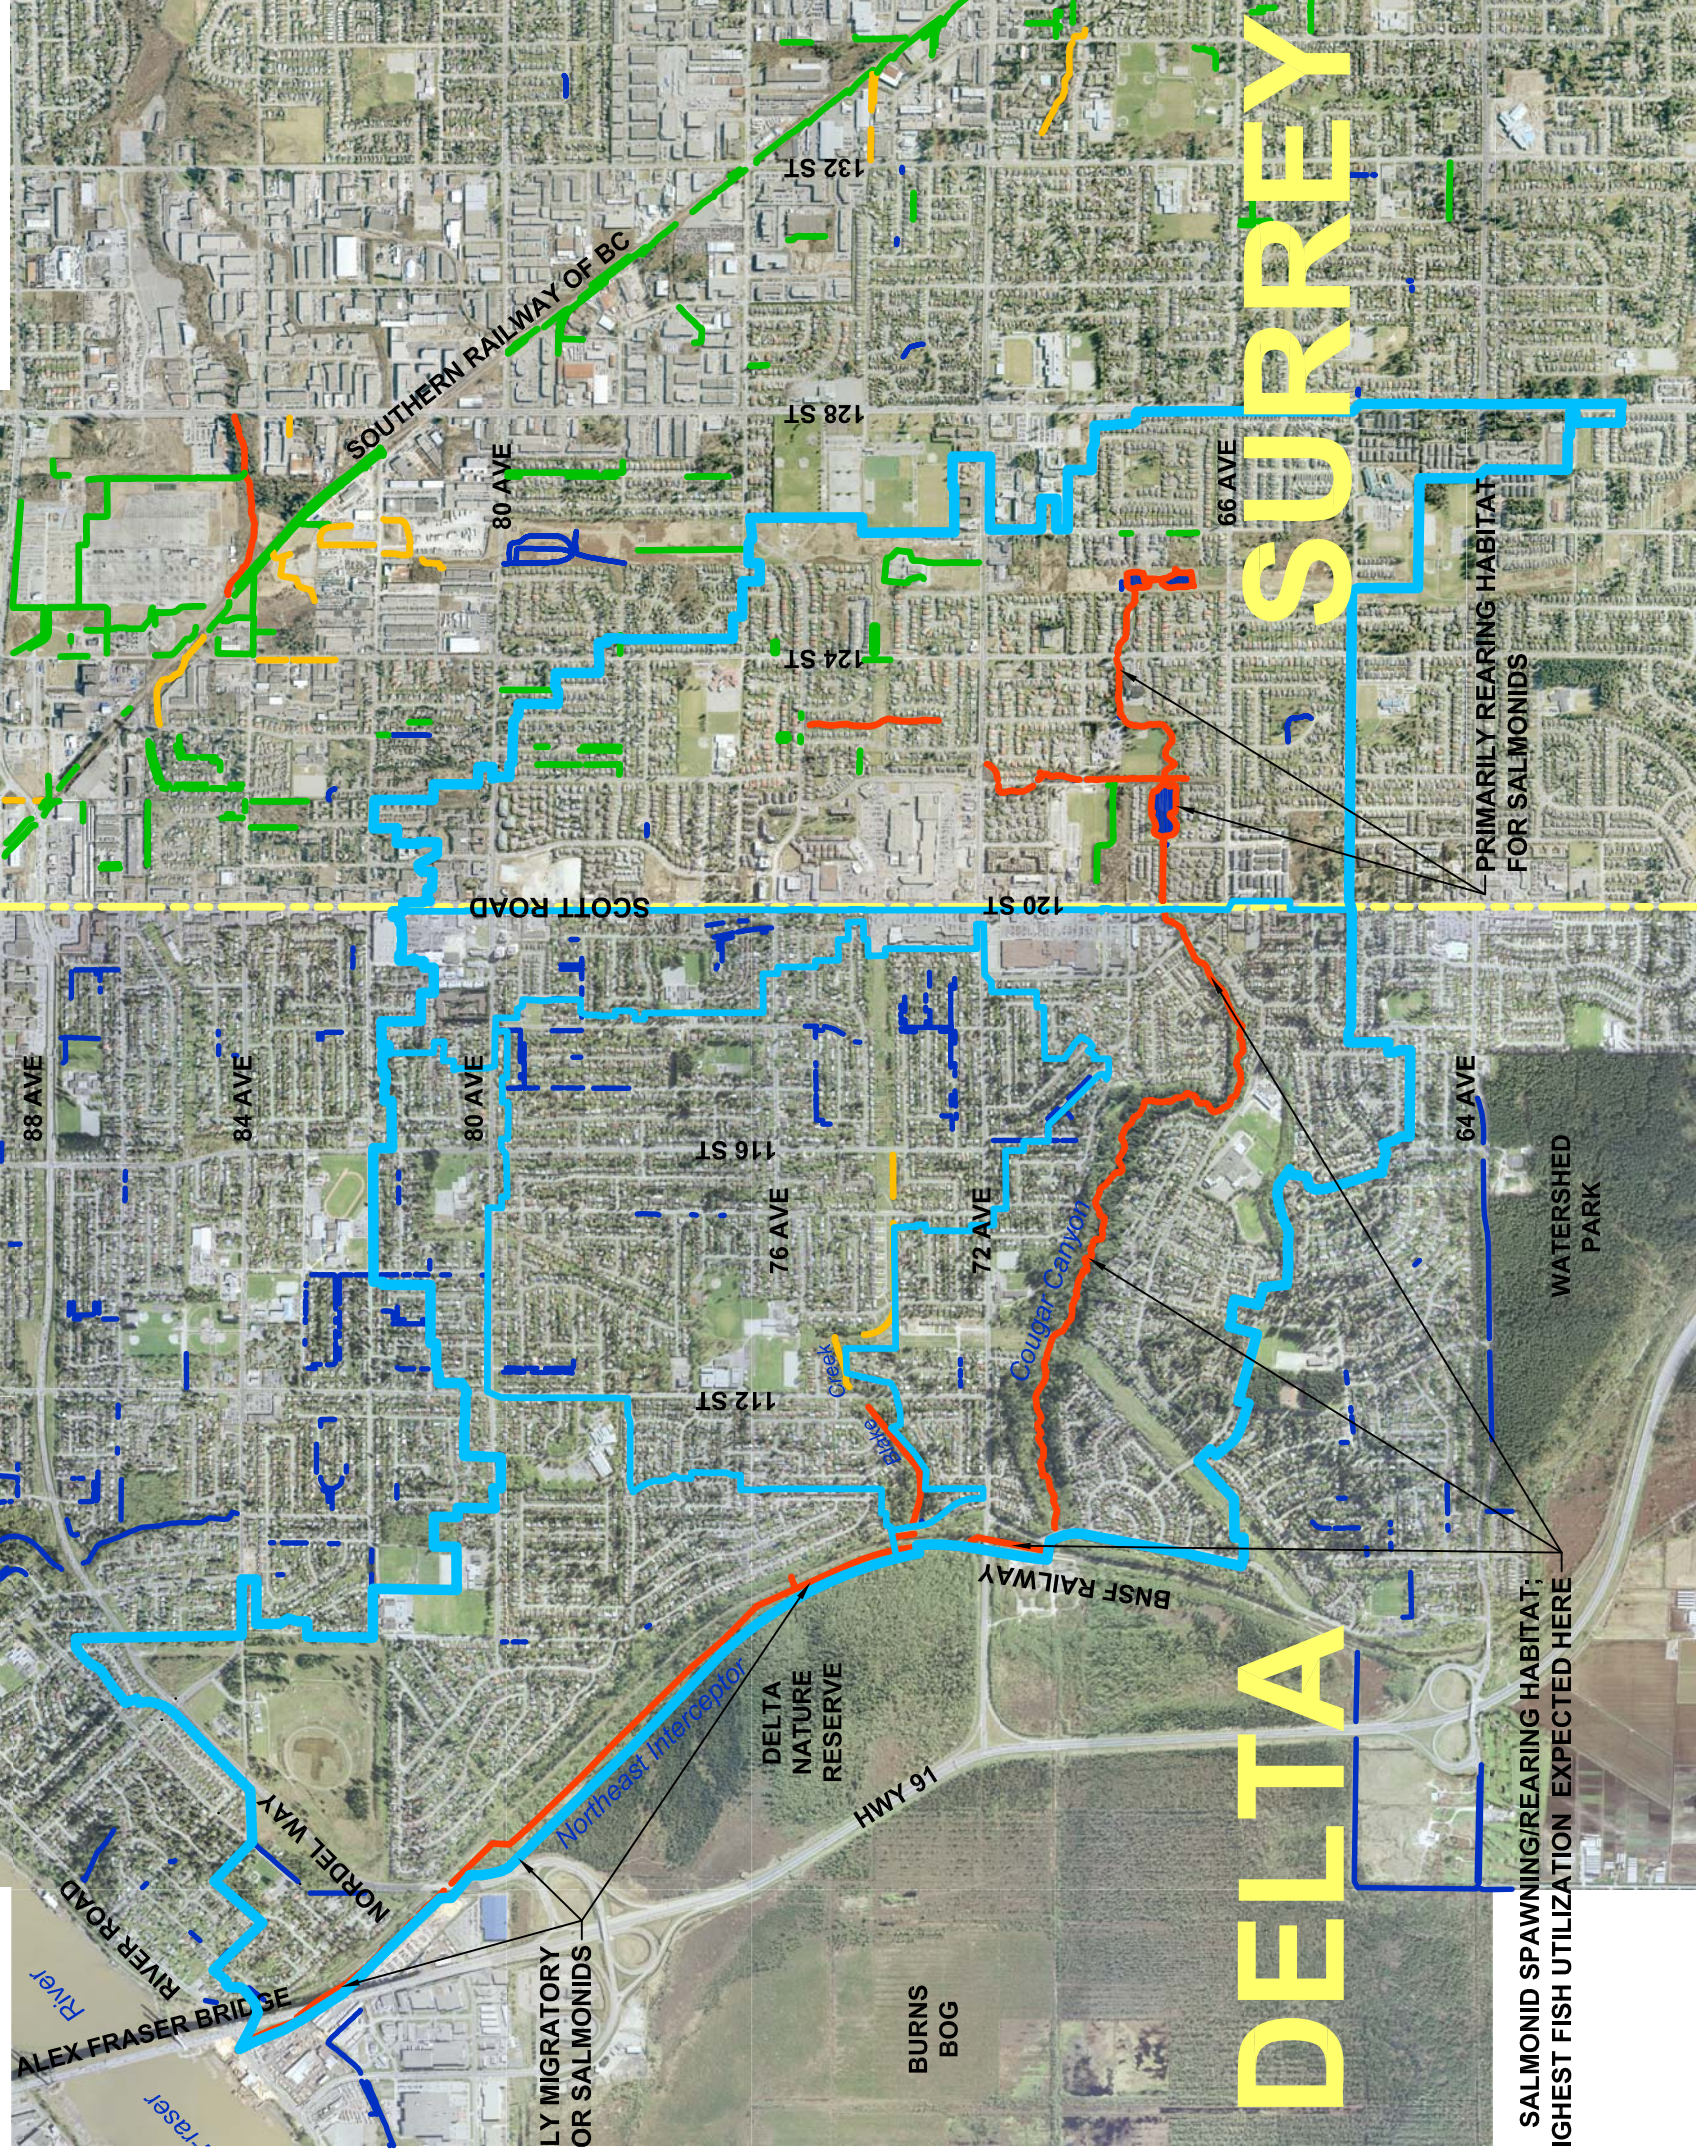
PROJECT	COUGAR CREEK INTEGRATED STORMWATER MANAGEMENT PLAN	PROJECT NO.	06-6904
TITLE	STREAM CLASSIFICATION	FIGURE NO.	2-11

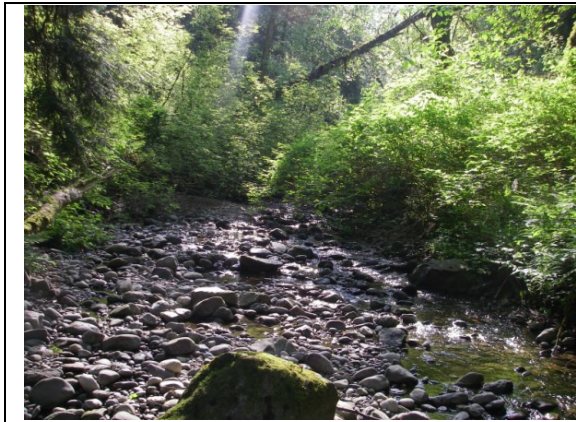
Photo 8: Site CC2 – Looking Upstream

The 'middle' sample site was located within a deep ravine with extensive and established riparian vegetation on both sides of the creek (**Photographs 8 and 9**). The creek at this location exhibited run/riffle/pool complexes, with large boulders and large woody debris. Wetted width ranged from 2-6m, with a bankfull width of 8-12m. Water depth was ~10cm at the time of sampling. The substrate was clean, ~80% embedded, and consisted of boulders, cobble and coarse gravel.

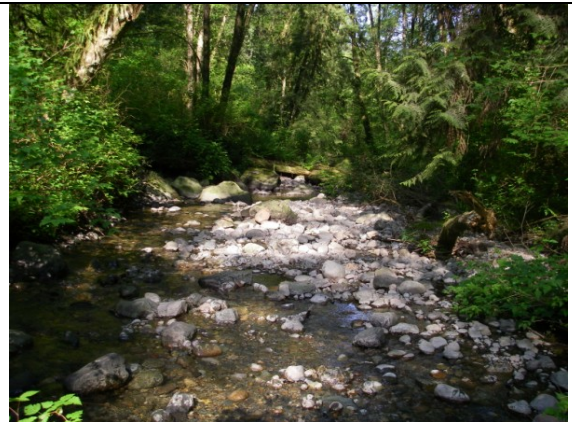
Photo 9: Site CC2 – Looking Downstream

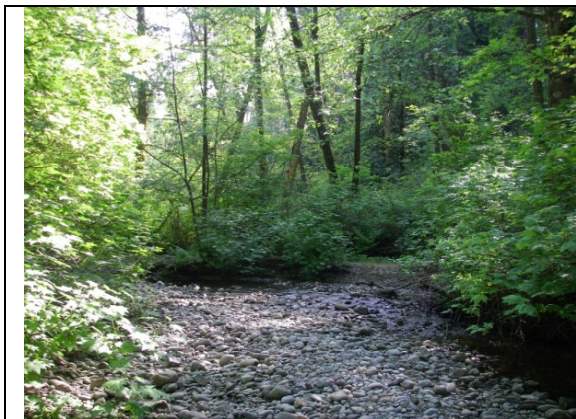
Photo 10: Site CC3 – Looking Upstream

Cougar Creek approximately 100m upstream (east) of the sediment sump at Westview Drive is a wide, meandering channel that exhibits run/riffle/pool complexes (**Photographs 10 and 11**). An intact, established riparian vegetation buffer exists on both sides of the creek, consisting of a deciduous canopy with extensive shrub understory. The cobble-dominated substrate is clean, and ~60% embedded. Wetted width ranged from ~2-4m, with a bankfull width of 8-12m. Wetted depth was ~15cm (~30-40cm in pools) at the time of sampling.

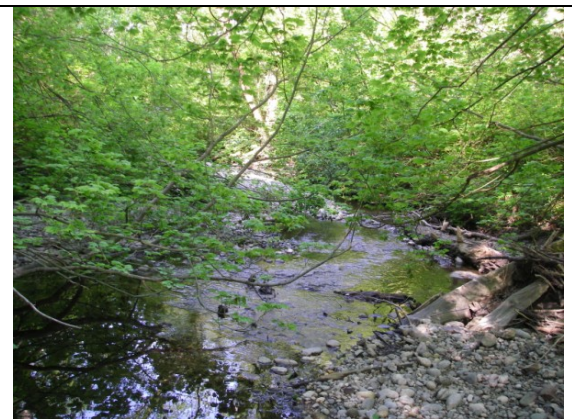
Photo 11: Site CC3 – Looking Downstream

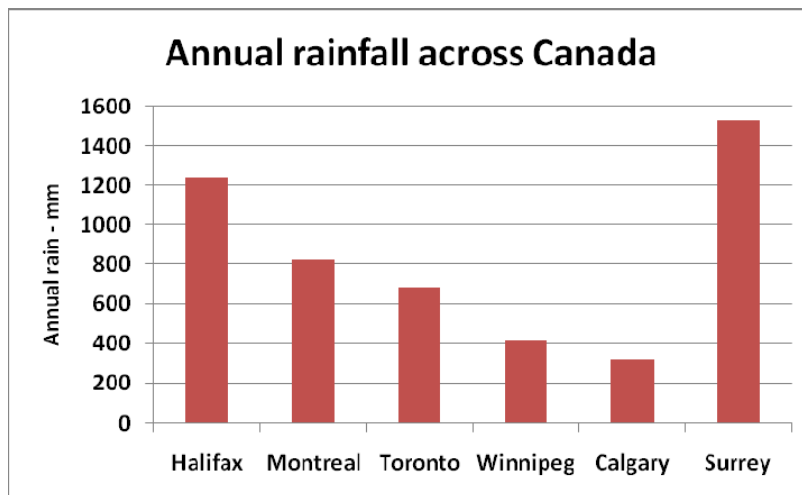
Figure 3-1: Long Term Annual Rainfall across Canada

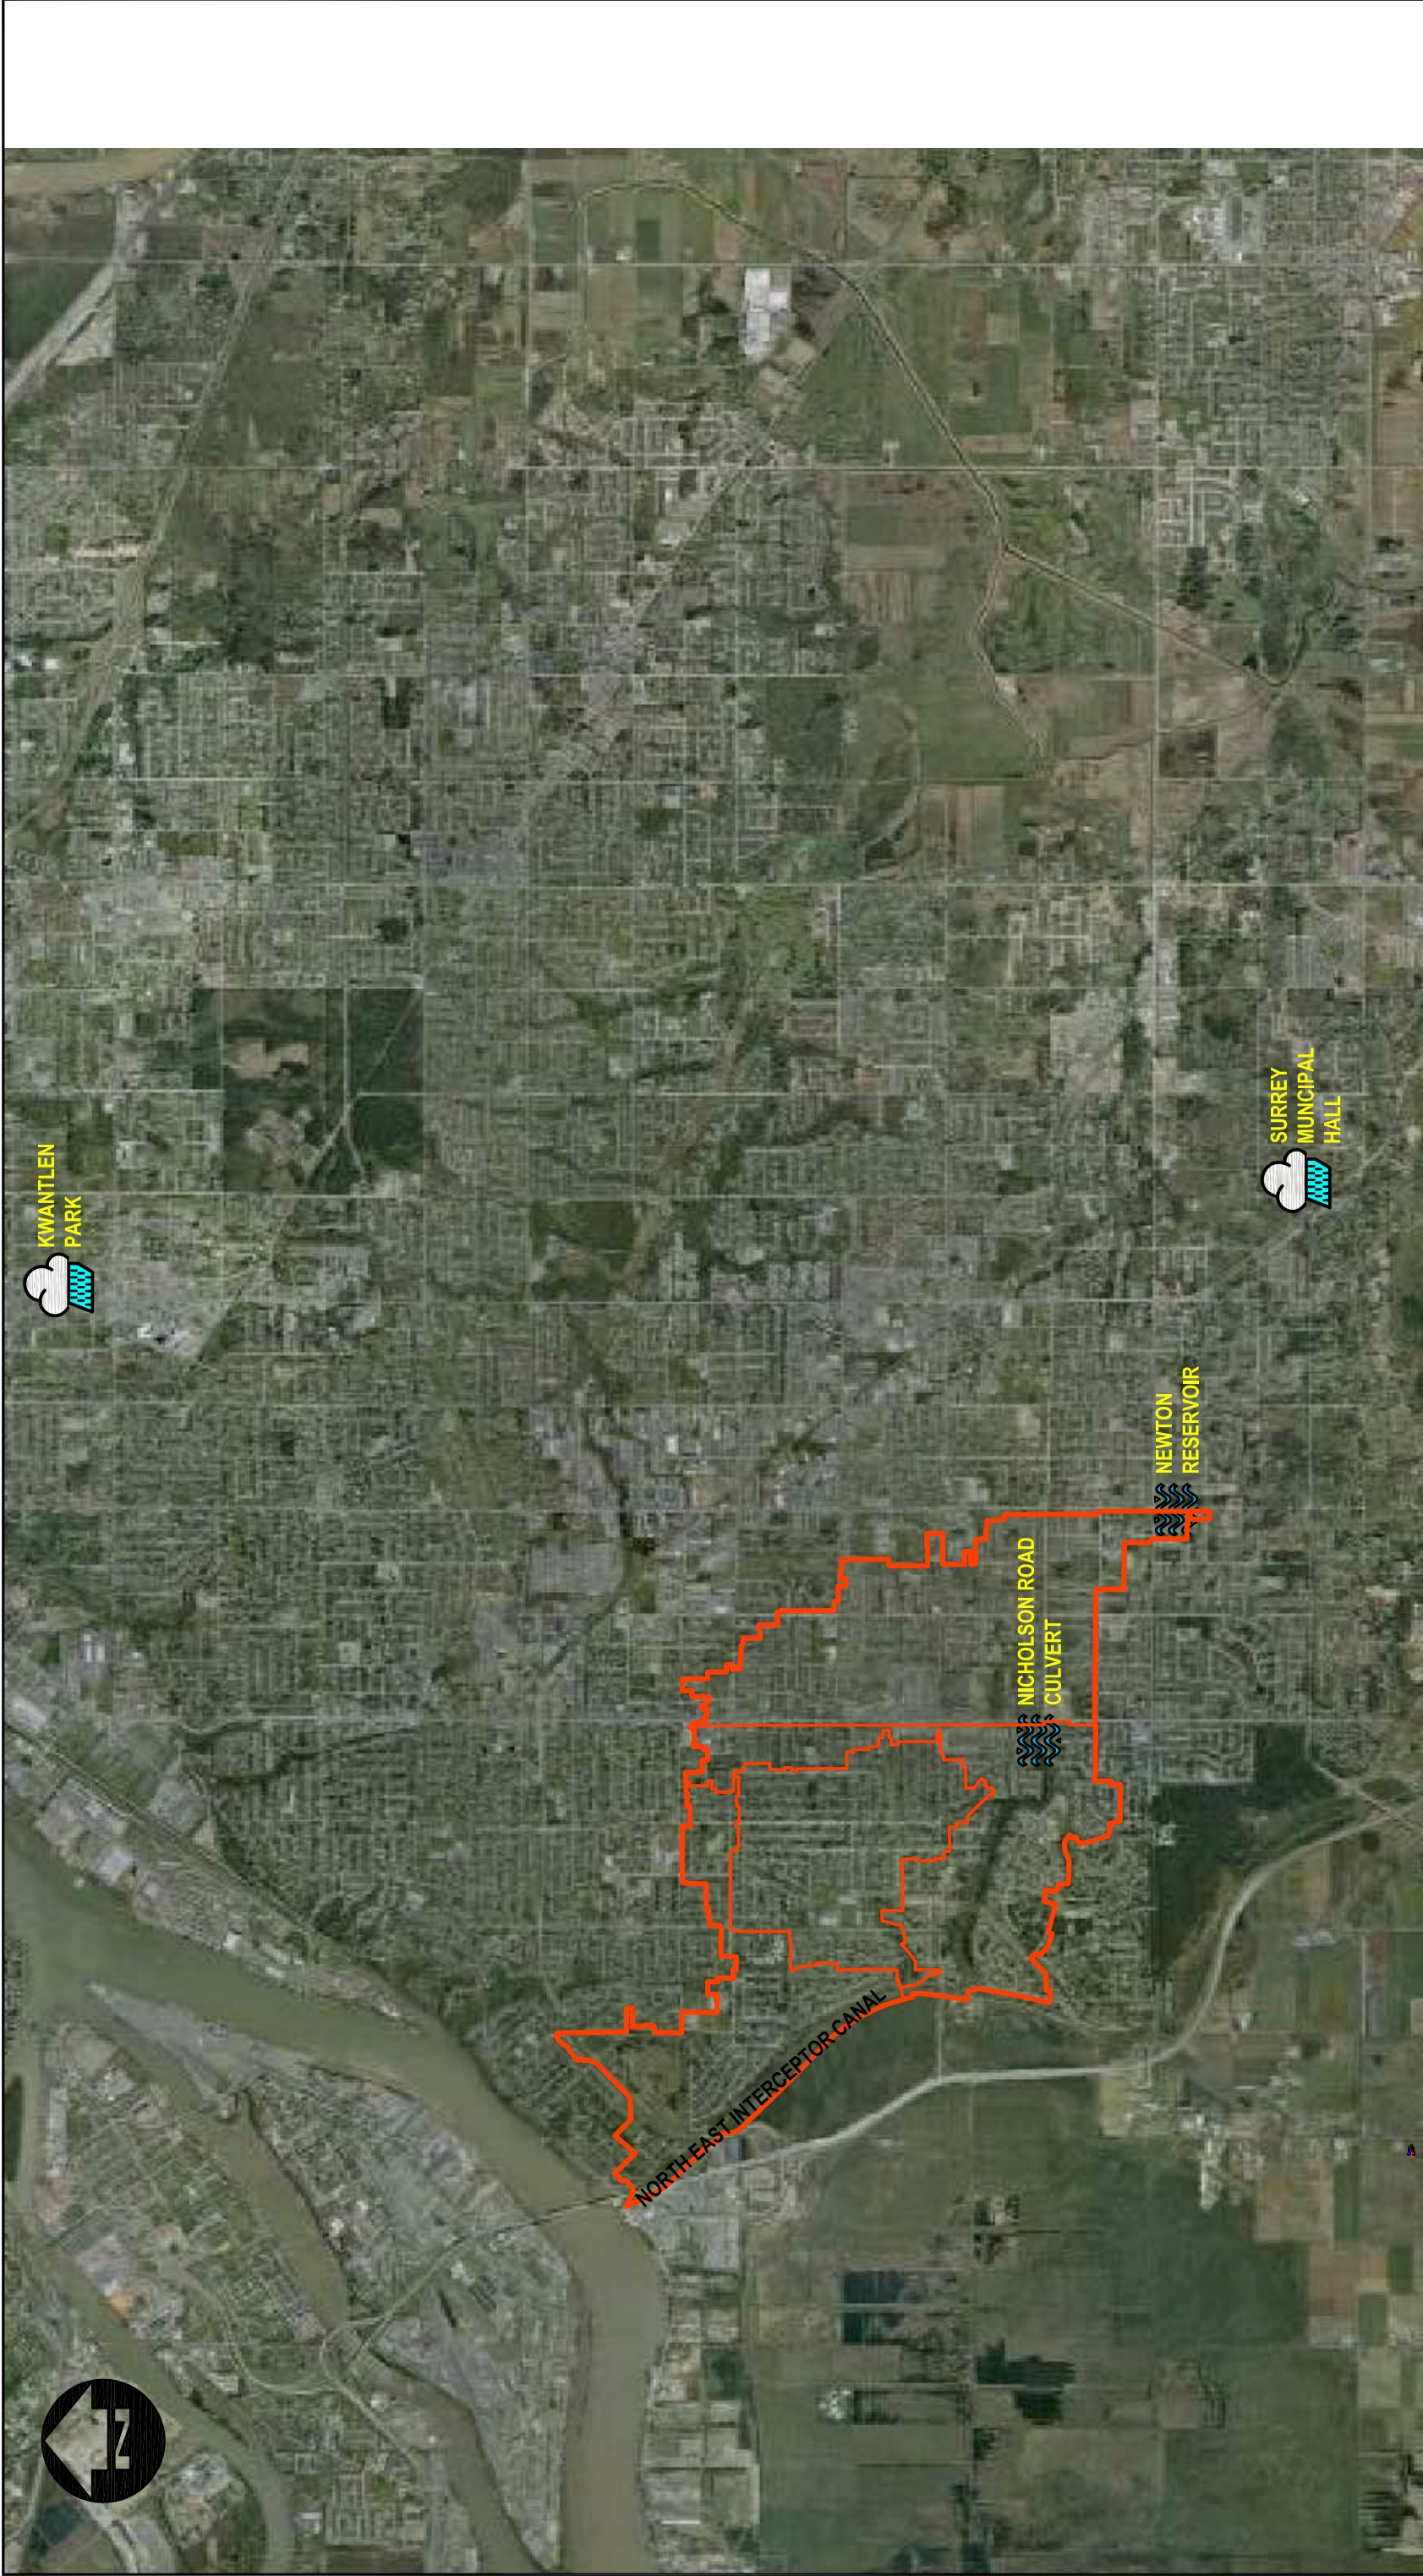
Two long-term rain gauges were selected to provide the study area rainfall statistics: Municipal Hall and Kwantlen Park, and one short-term station located at the Newton Reservoir, shown on **Figure 3-2** and listed in **Table 3-1**

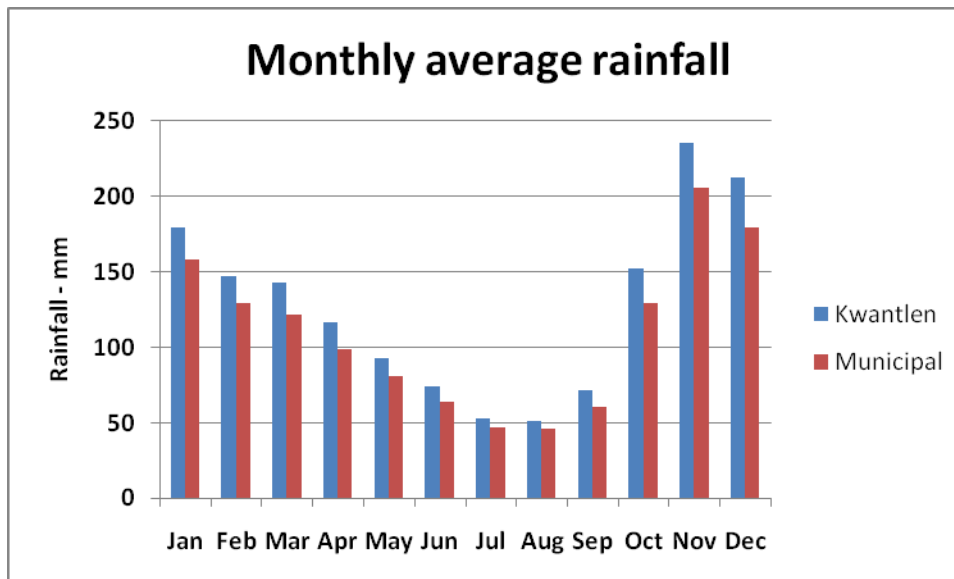
Figure 3-3: Monthly Average Rainfall at Surrey Municipal and Kwantlen Gauges

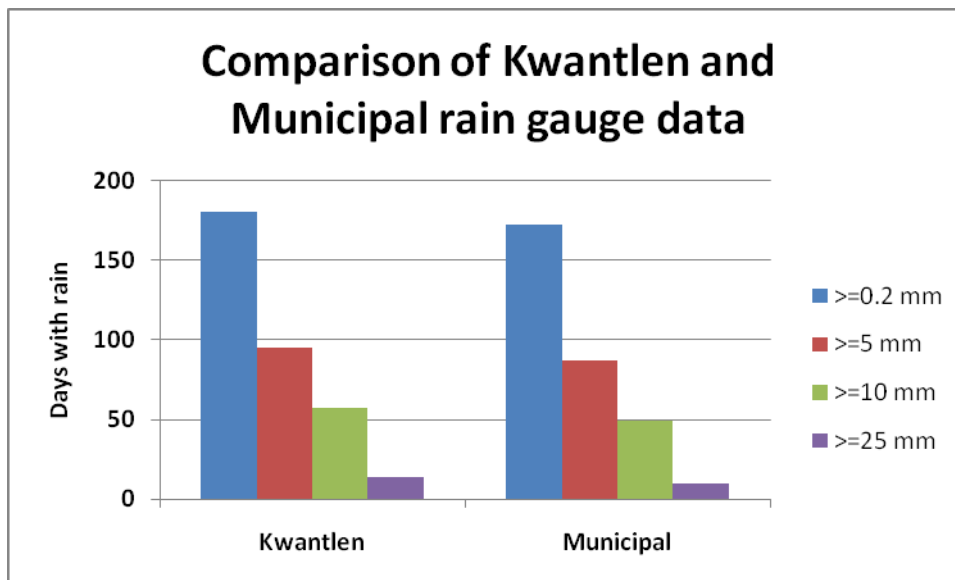
A second analysis of the long-term data recorded at the two gauges examined the number of days with ≥ 2 mm, ≥ 5 mm, ≥ 10 mm and ≥ 25 mm of rain as shown on **Figure 3-4**. This resulted in very similar patterns.

Figure 3-4: Comparison of Days with Rain at the Two Gauges

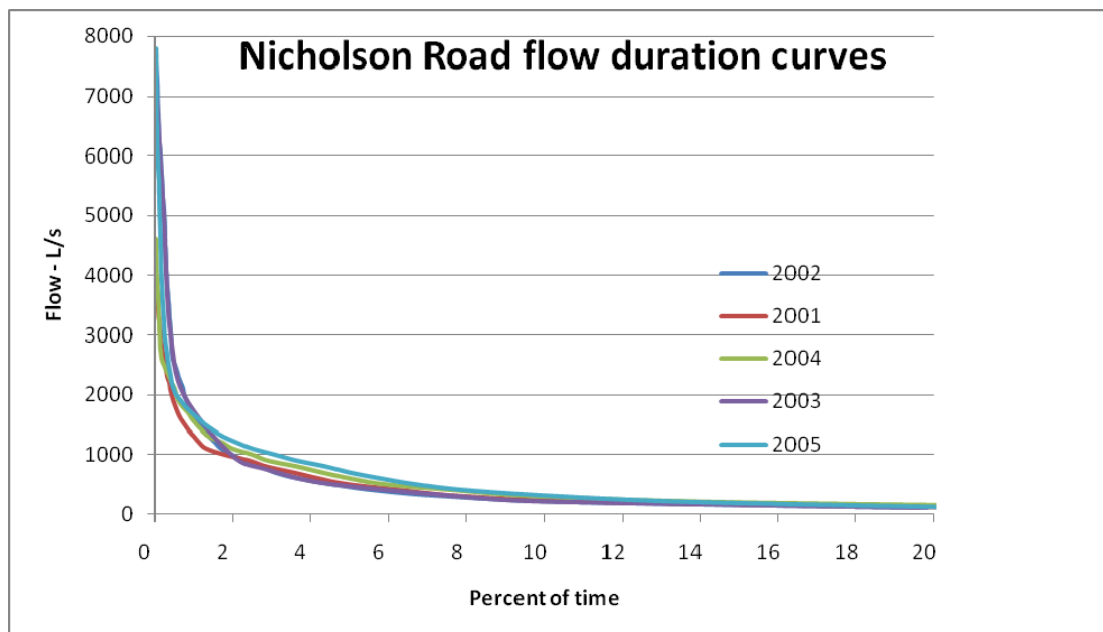
Figure 3-5: Flow Duration Curves at Nicholson Road Gauge

Generally, the five curves show a similar flow-duration distribution. Flows in excess of 1,000 L/s only occur 2%-3% of the time in a year. Based on the five years of Nicholson Road flow data, flow duration estimates were prepared for flows up to 1000 L/s for wet and dry years as indicated in **Table 3-4**.

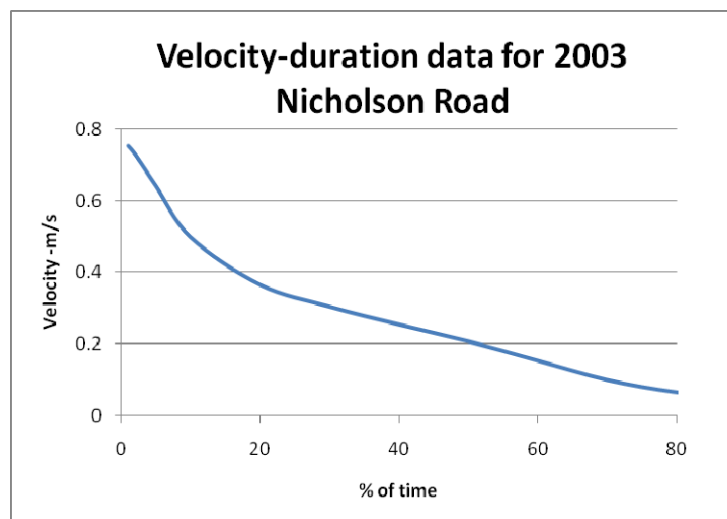
Figure 3-6: Velocity-Duration Graph for 2003

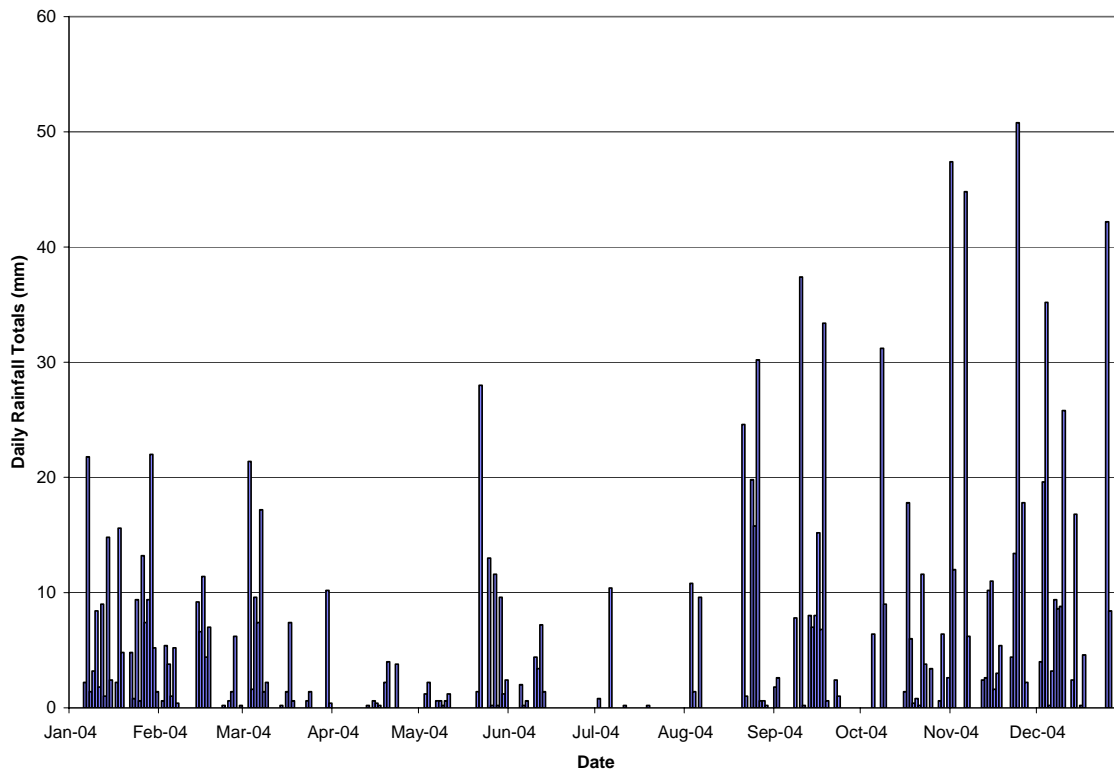
Figure 3-8: Newton Reservoir Hyetograph for 2004

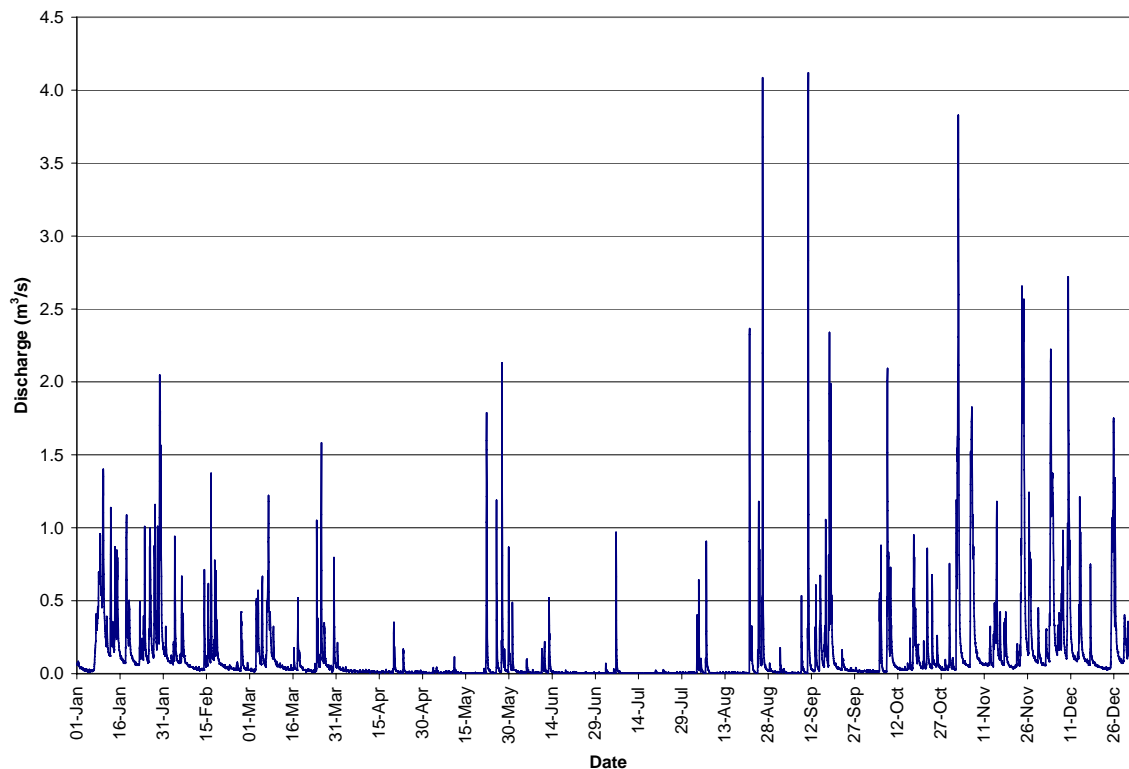
Figure 3-9: Cougar Creek Flows Observed at Nicholson Road Culvert - 2004

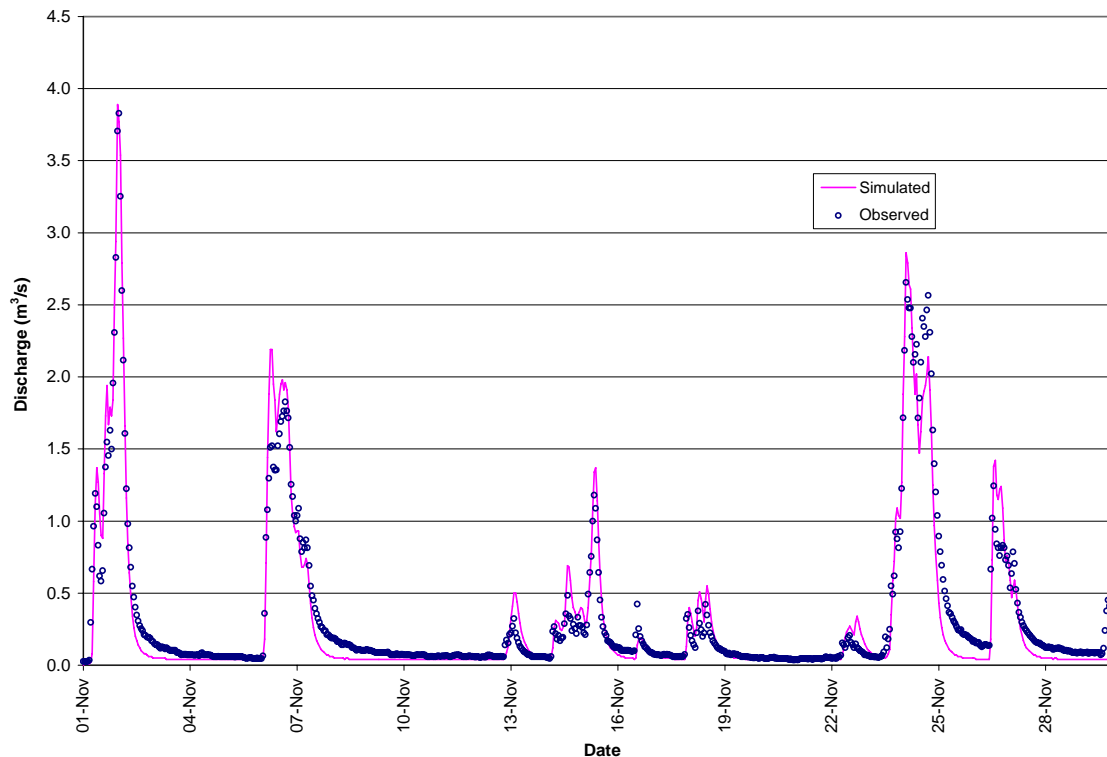
The subcatchment parameters that were adjusted during calibration were slope, representative catchment width, surface roughness, depression storage coefficients, and Horton's infiltration parameters. A comparison of simulated and measured hydrographs for November 2004 is shown on **Figure 3-10**. The two hydrographs show a good visual fit of the simulated hydrograph for the November 2004 period compared with the observed flow record. The modelled peak flows and hydrograph response matched closely with observed with some deviation on the receding or falling limb of the runoff event. Comparisons of the modelled 2004 simulation illustrated that, in general, the simulated hydrograph response matched the observed.

Figure 3-10: Nicholson Road Simulated and Observed Flows for November 2004

The annual water balance for the 2004 modelled year was within 10% of observed estimated flow volumes. The simulated runoff volume was 911 mm over the catchment basin size of 475.9 ha compared with the observed runoff volume of 825 mm.

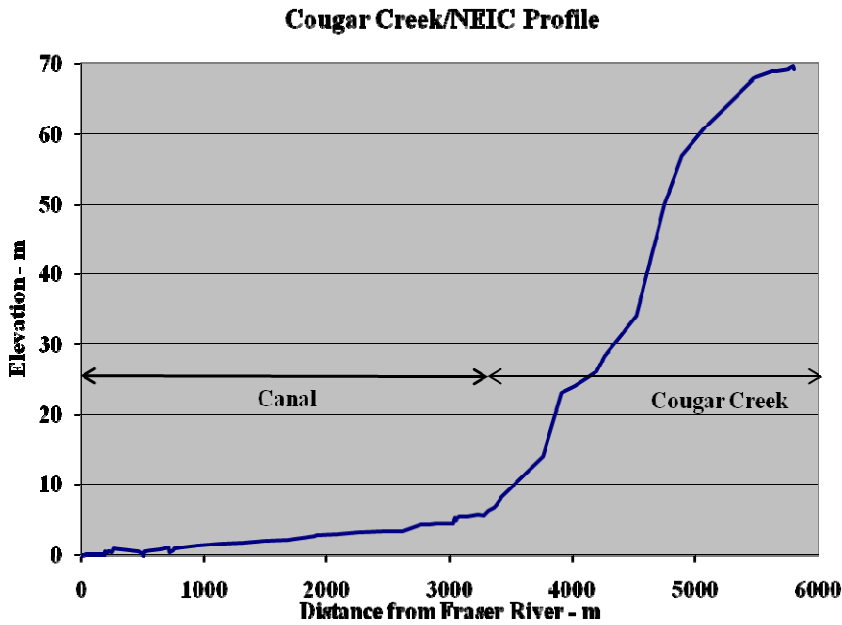
Figure 3-11: Bed Profile of the Cougar Creek/NEIC System

The computer results showed that once the high flows pass the steep gradient of Cougar Creek and enter the Canal, which has a very flat gradient, the Canal would not be capable of conveying the high flows; instead it would store the flood volume temporarily in the open channel and behind crossings, and release it to the Fraser River in lower flood peaks but over a longer duration. **Figure 3-12** illustrates this phenomenon by comparing hydrographs at Westview Drive near the bottom of Cougar Creek and near the outlet to Fraser River.

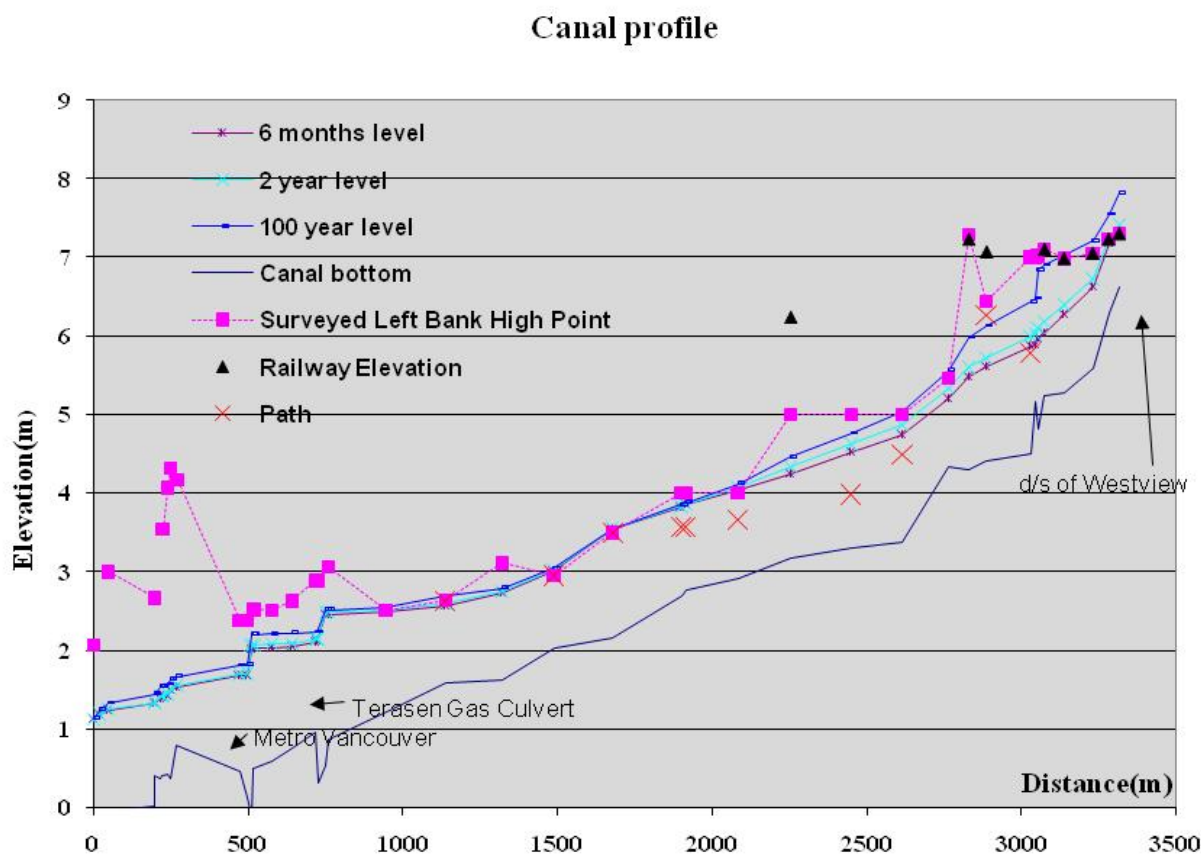
Figure 3-13: Canal Profile
