Cougar Creek/Northeast Interceptor Canal INTEGRATED STORMWATER MANAGEMENT PLAN FINAL REPORT

JUNE 2009

Submitted by:
Dillon Consulting Limited
130 – 10691 Shellbridge Way
Richmond, BC V6X 2W8

Project Nos.: 06-6904 and 06-6987

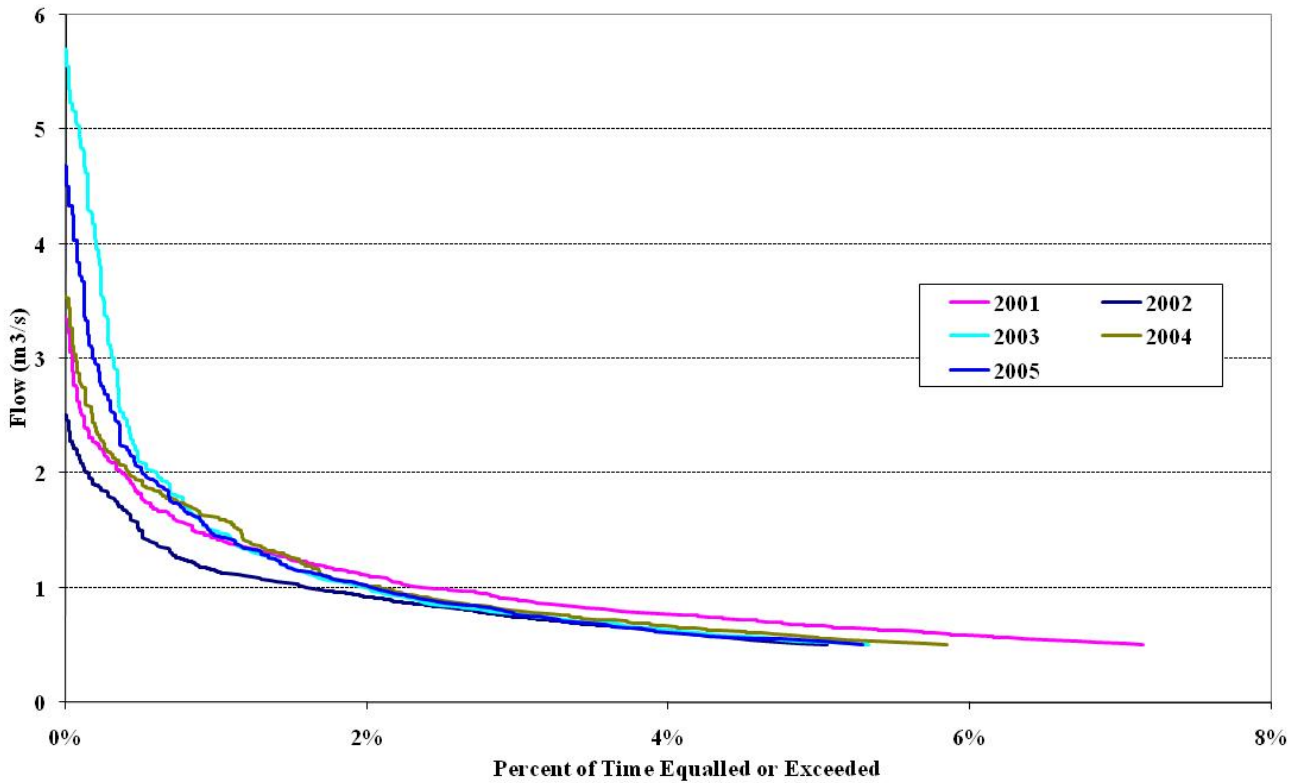
**Cougar Creek at Nicholson Road Flow Duration >500 L/s Duration
 2001-2005, existing condition**

The calibrated continuous model was run for the 2001-2005 period to simulate five years of runoff in the Cougar Creek/NEIC system. The resulting flow-duration curves incorporate the storage effect of existing stormwater management facilities located upstream. The five year plot shows similar pattern for the five years of flows at Nicholson Road; generally a peak flow of 1 m³/s is only exceeded approximately 2 % of the time (approximately half a day) in a year.

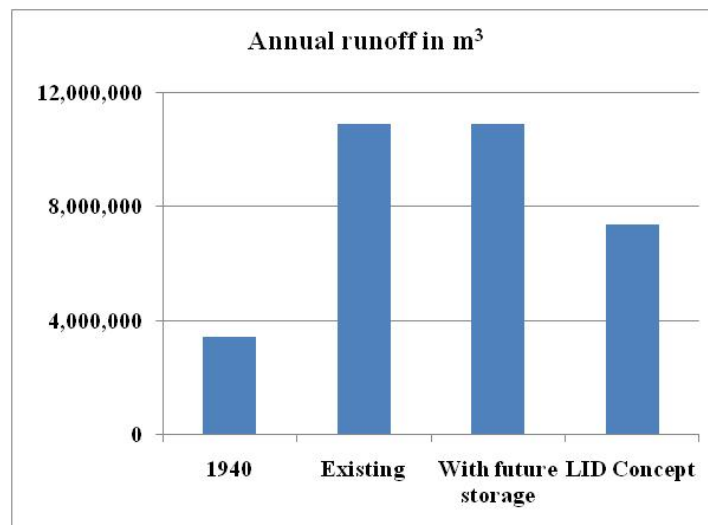
Figure 3-16 shows the significant increase in annual runoff volumes caused by the past decades of urbanization. This increase is the result of impermeable surfaces discharging a much higher percent of rainfall runoff under current development conditions than during the pre-developed conditions. As the future scenario storage facilities would only provide a temporary storage to settle particles, the total annual runoff volume would be identical to the existing scenario.

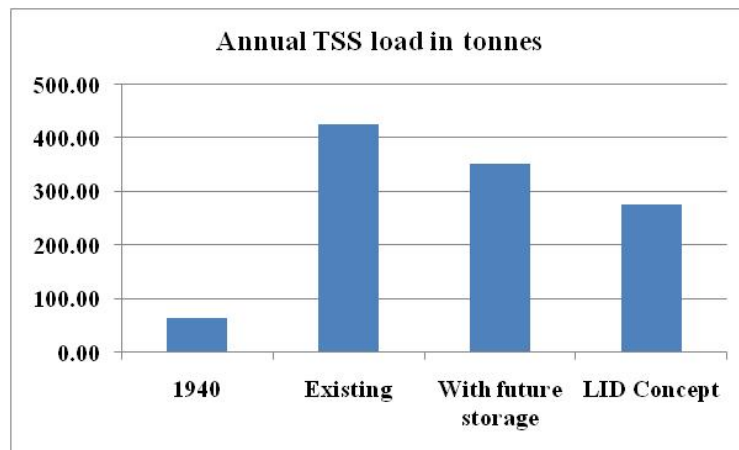
The Total Suspended Solid (TSS) estimates illustrated on **Figure 3-17** also shows large increases in the annual loads over the past years. This large increase is due to the combination of higher concentrations of TSS and higher runoff volumes generated in urban areas. The model also showed that even with stringent future runoff control from residential areas, the total annual TSS load cannot be lowered to approach the 1940 conditions. When considering the total load estimates, it is important to emphasize that the total does not include the substantial bedload movement in the creek. For example the sediment trap at the bottom of the Cougar Creek Canyon can accommodate a similar load of sediment, an amount which is deposited at least annually.

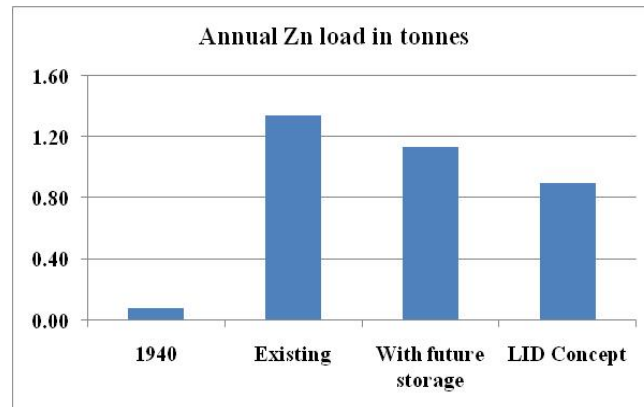
Figure 3-19: Annual Zn Load in Tonnes

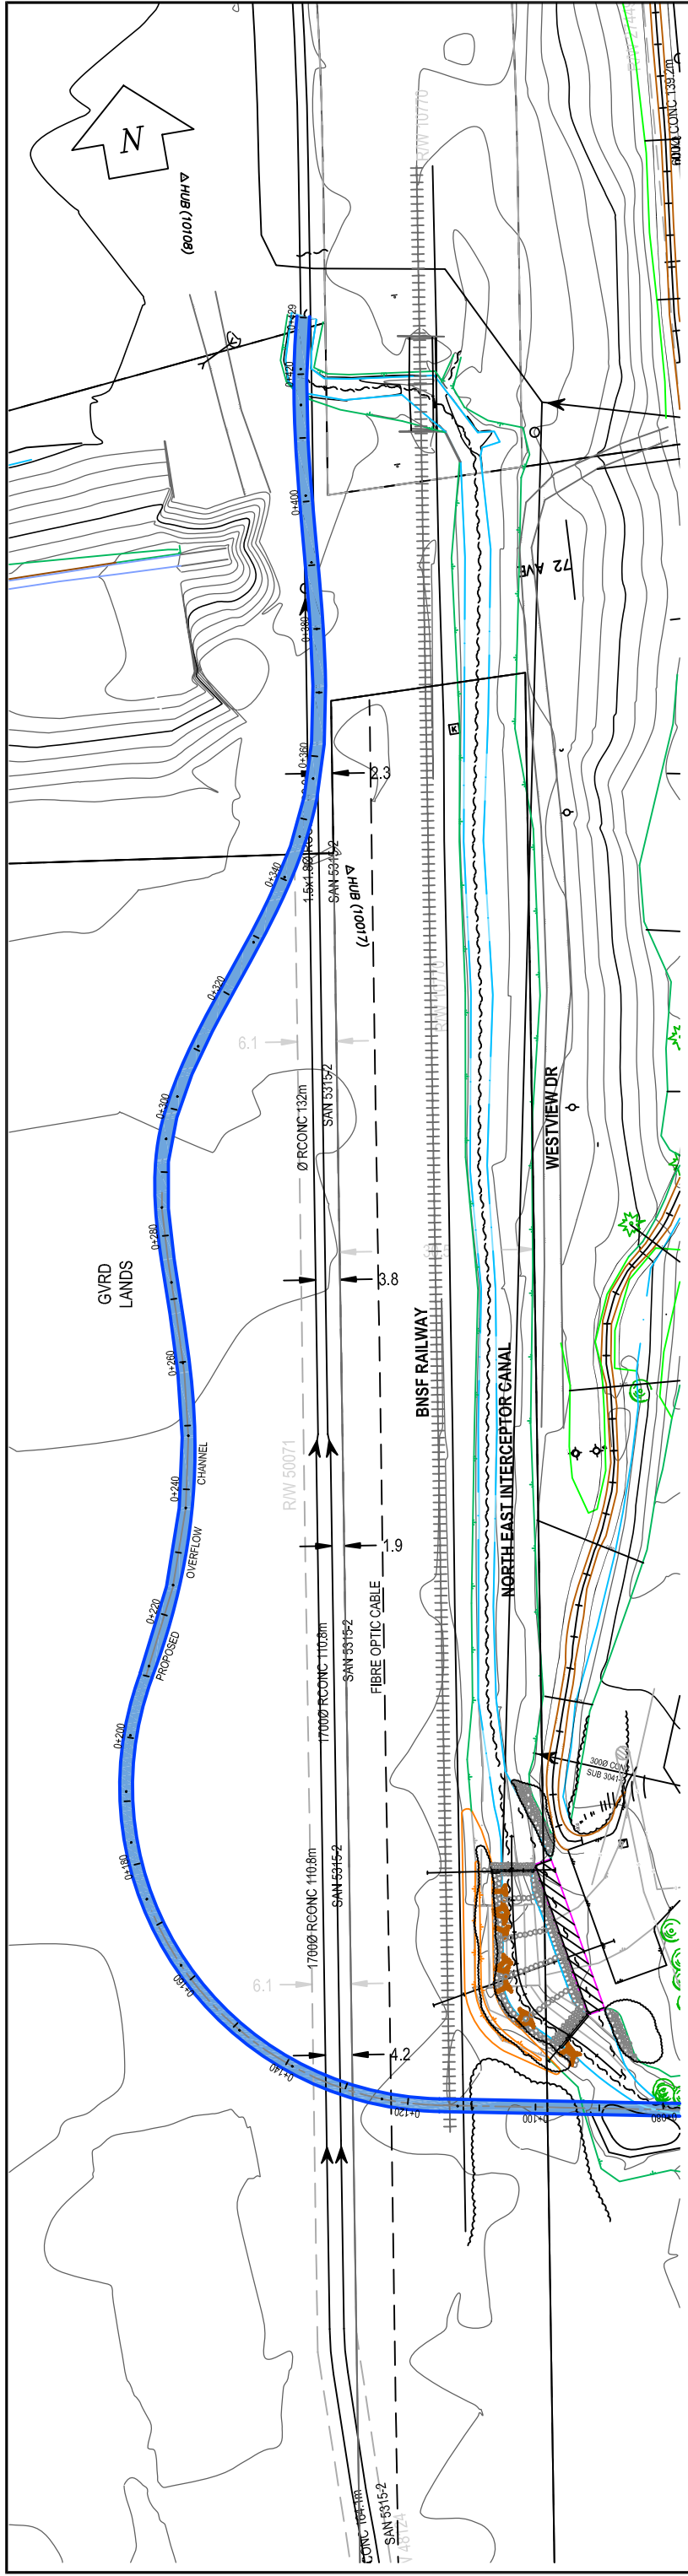
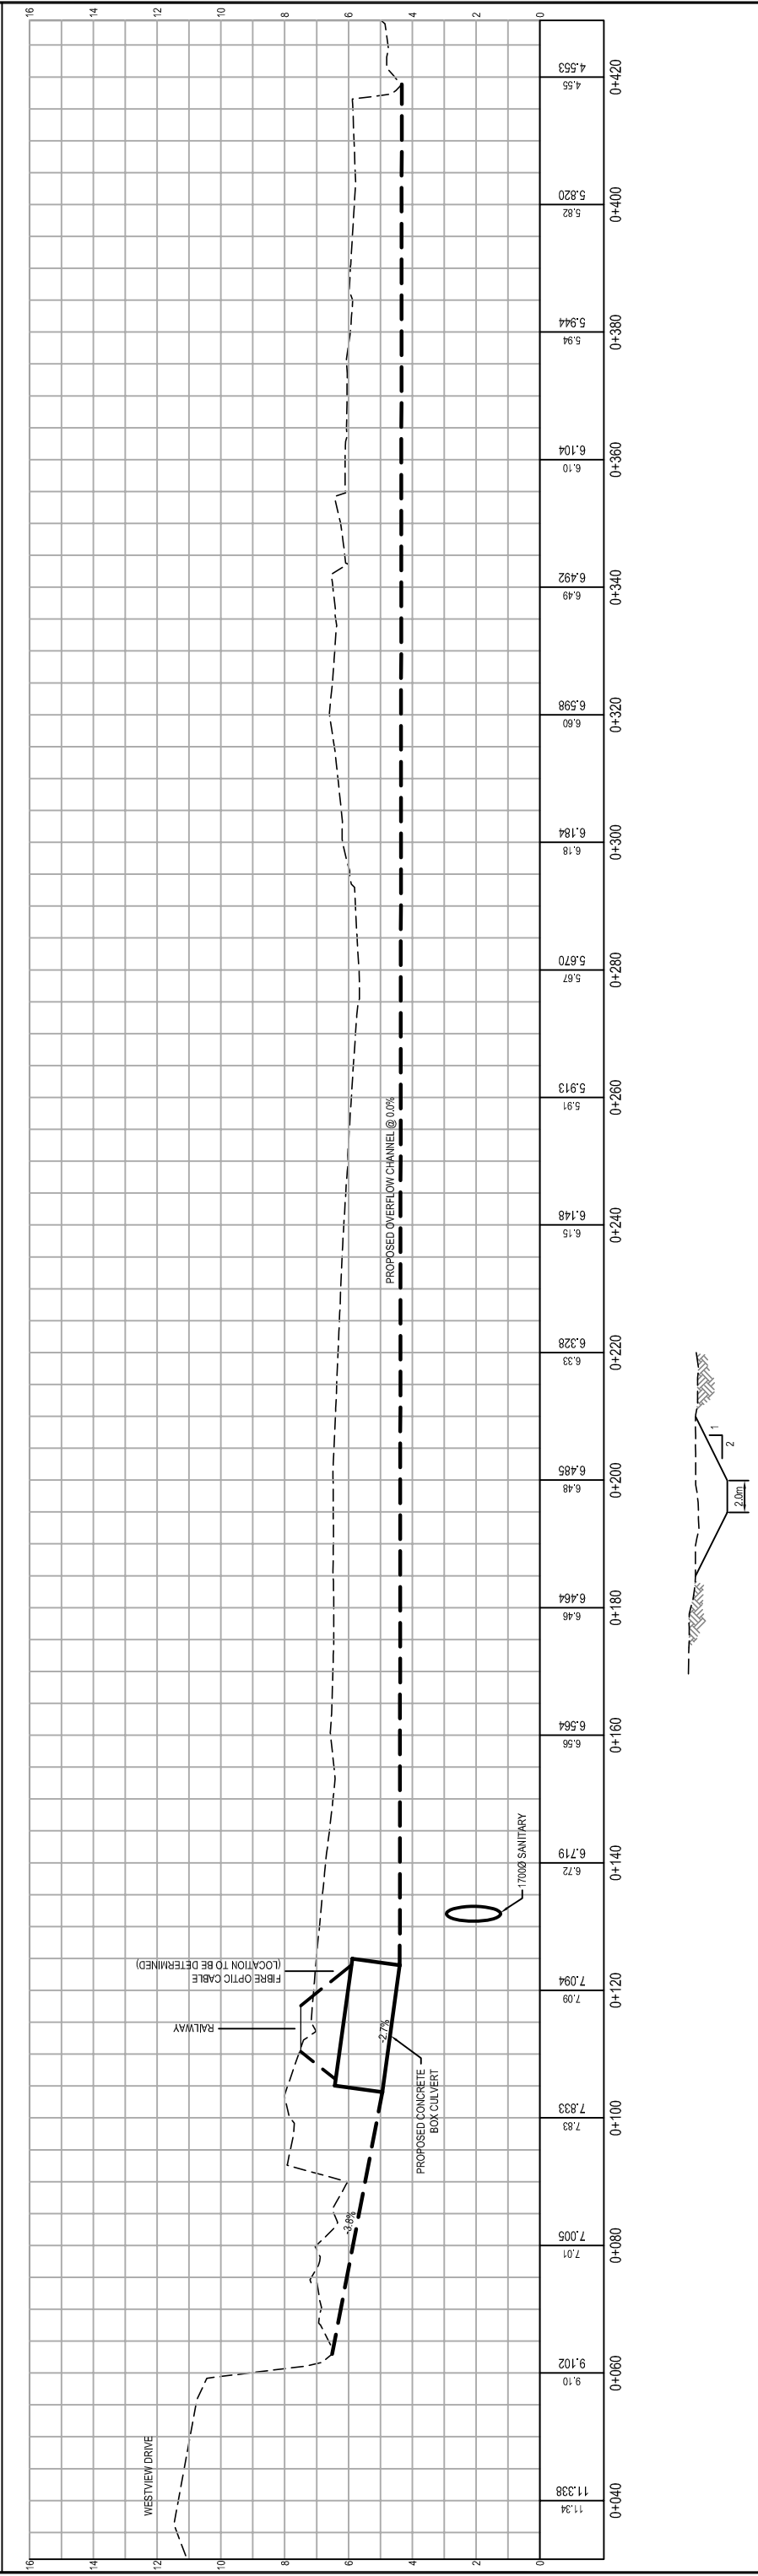
(A) PROPOSED CHANNEL SECTION
SCALE: NOT TO SCALE

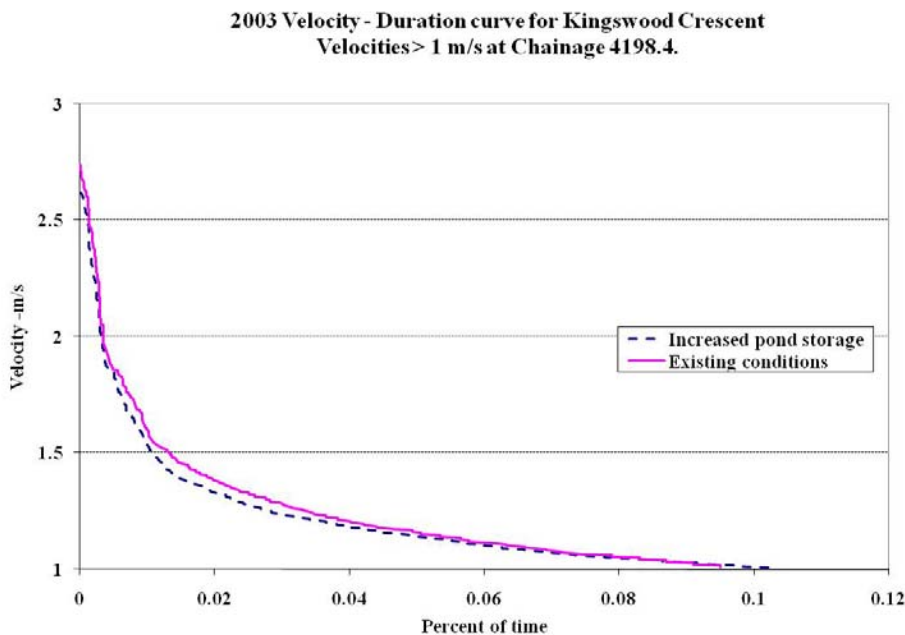
Figure 4-8: Velocity-Duration at Kingswood Crescent

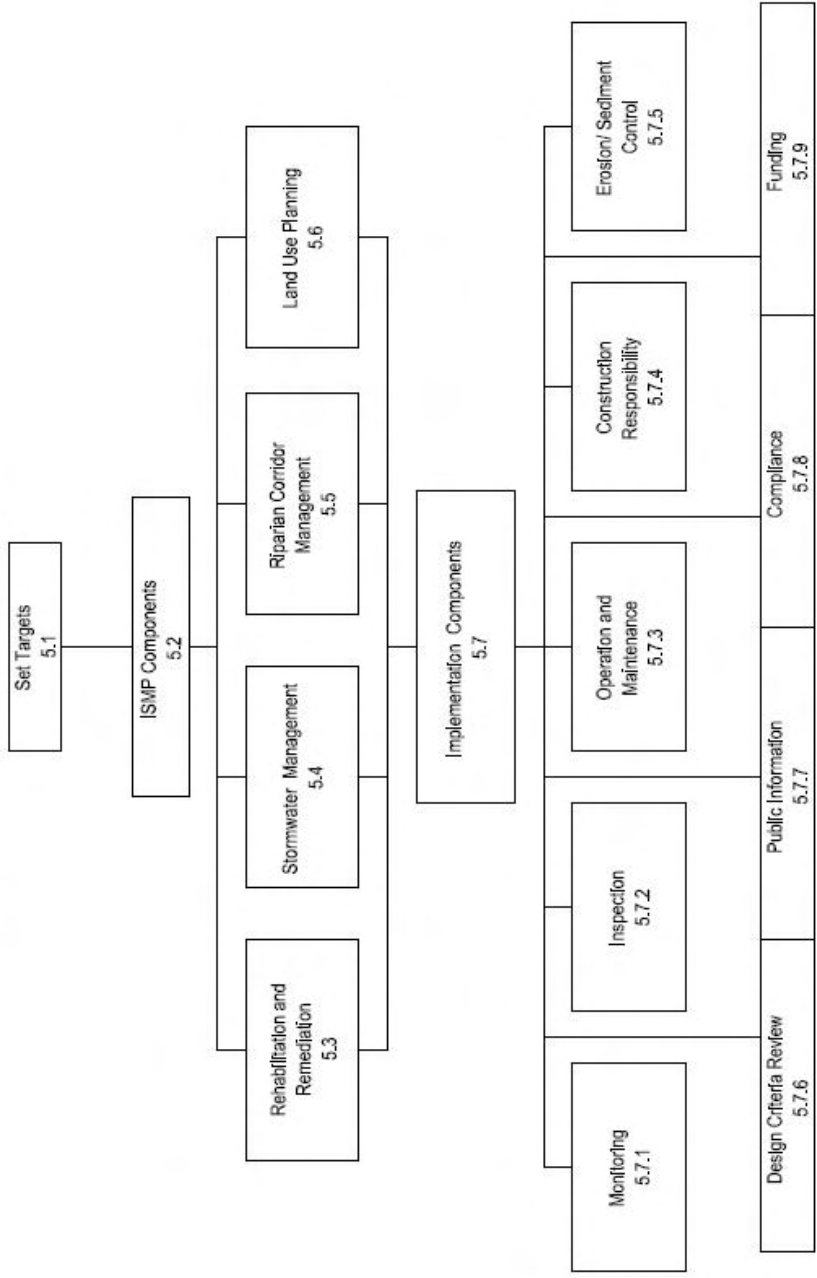
DILLON CONSULTING	PROJECT NORTH DELTA INTEGRATED STORMWATER MANAGEMENT PLAN	PROJECT NO. 06-6904
DATE MARCH 2009	TITLE INTEGRATED STORMWATER MANAGEMENT PLAN FLOW CHART	FIGURE NO. 5-1

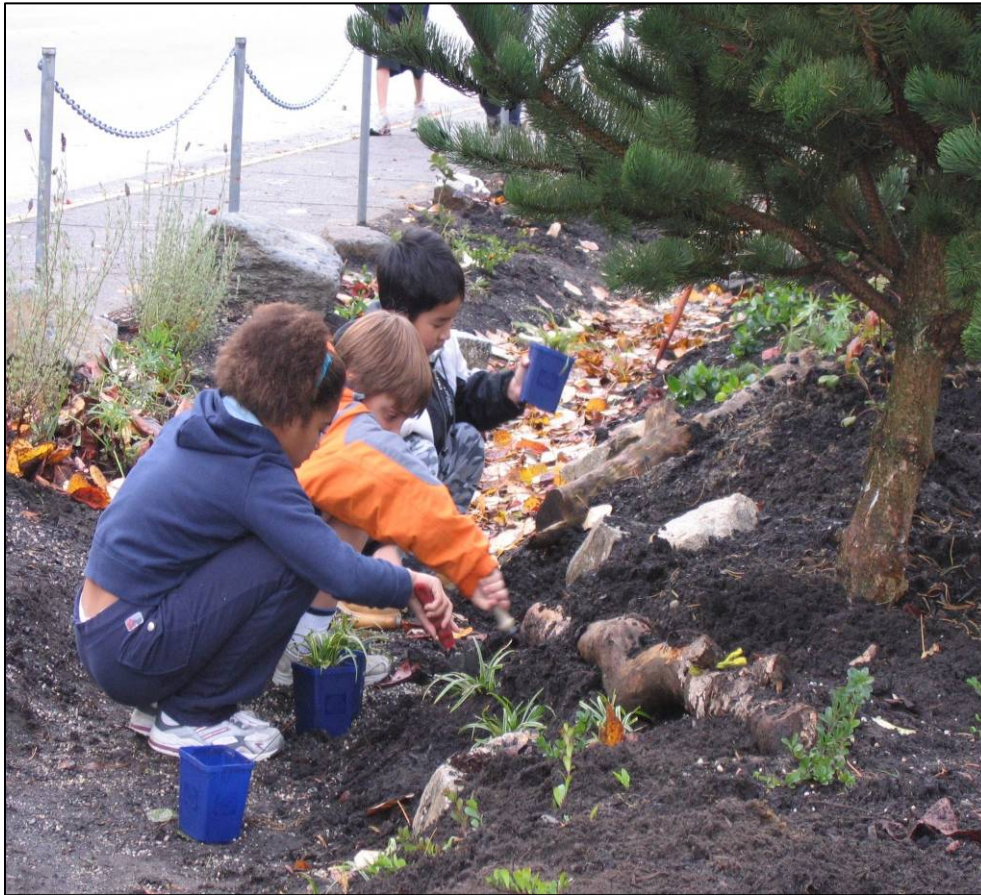
Photo 12: Cougar Canyon Elementary School Raingarden
