City of Delta  
**DRINKING WATER  
QUALITY REPORT**  
2025

# DRINKING WATER QUALITY REPORT 2025

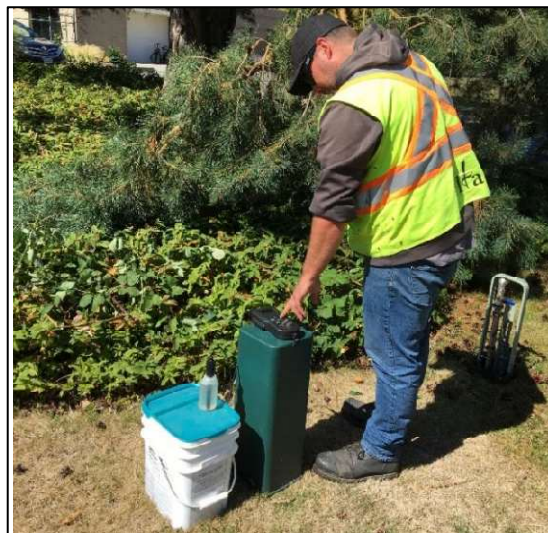
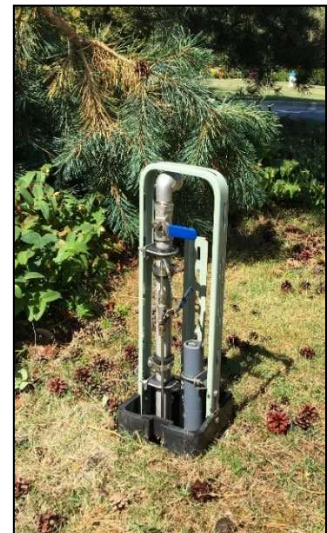
**Figure 2: Water Quality Technician Sampling Water**

The City's Water Quality Technician samples and tests water from 33 sampling sites each week. This year, three more sampling stations were installed and will begin sampling in 2026. Samples are tested on-site for microbiological characteristics to provide early indication of any issues. In accordance with the 24<sup>th</sup> Edition of Standard Methods for the Examination of Water and Wastewater, an additional sample is taken and placed in a sterile bottle. The sample is marked with the location and time of day before being placed into a cooler. At the end of each day, samples are sent to the MV laboratory where the water is tested for said characteristics. The MV laboratory is a member of the Standards Council of Canada and is an accredited laboratory with the Canadian Association of Environmental Analytical Laboratories. **Figure 2** shows the technician taking a sample at Clarence Taylor Crescent Water Sampling Station. Results are reported to the City's Water Quality Technician within seven days of submitting the samples. However, preliminary *E. coli* tests are reviewed within 24 hours and reported immediately should a positive result occur. **Appendix 7** details the reporting procedure for positive *E. coli* tests.

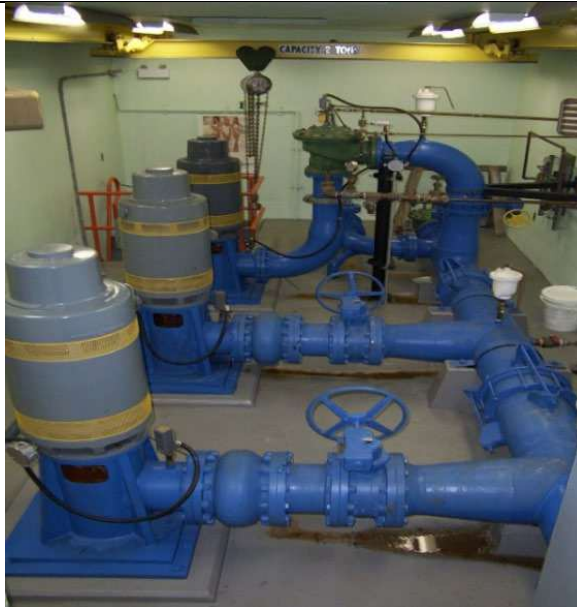
**Figure 9: Pump Station on 4 Avenue at Pebble Hill Reservoir**

The City water system includes three water storage and pump station facilities: Pebble Hill, Hellings, and Watershed Park. The Watershed Park pump station is the only installation that is owned and operated by the City and acts as an emergency backup water supply. The other two pump stations are operated in conjunction with Metro Vancouver. **Figure 9** shows the interior of the pump station at Pebble Hill Reservoir.

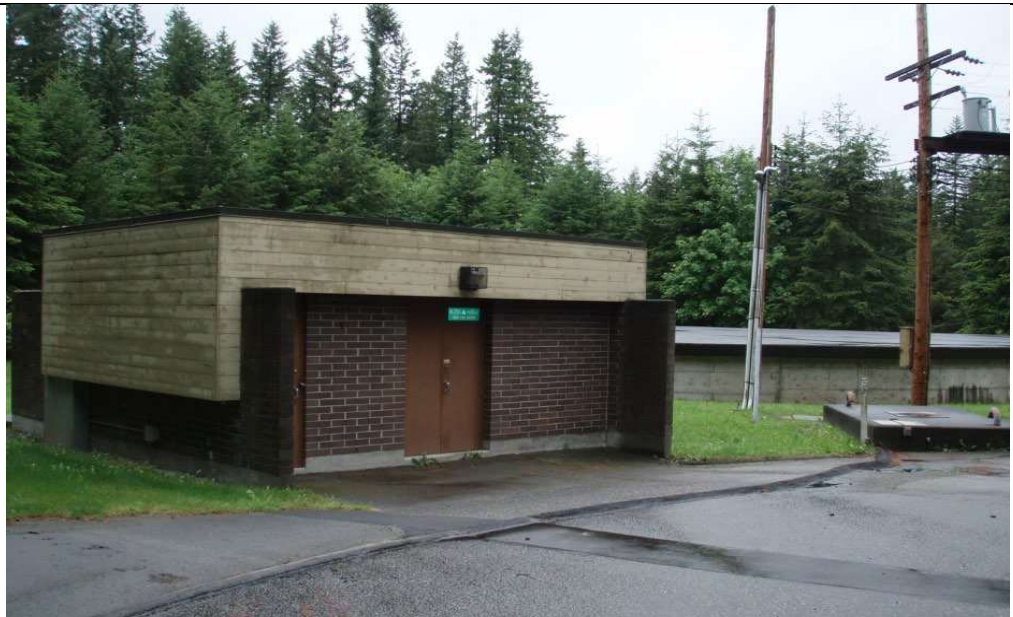
**Figure 10: Water Reservoir and Pump Station on 64 Avenue**

Two of the three water storage facilities in the City are owned and operated by MV: the Pebble Hill Reservoir in Tsawwassen and Hellings Reservoir in North Delta. The Watershed Park Reservoir (see **Figure 10**), with a capacity of 7,500,000 litres, is owned and operated by the City and is primarily filled with water from Metro Vancouver and the City's groundwater wells. The current reservoir structure was built in 1959 and is nearing the end of its service life. The reservoir is a key facility for water supply to East Delta and plays a vital role as an emergency water supply.

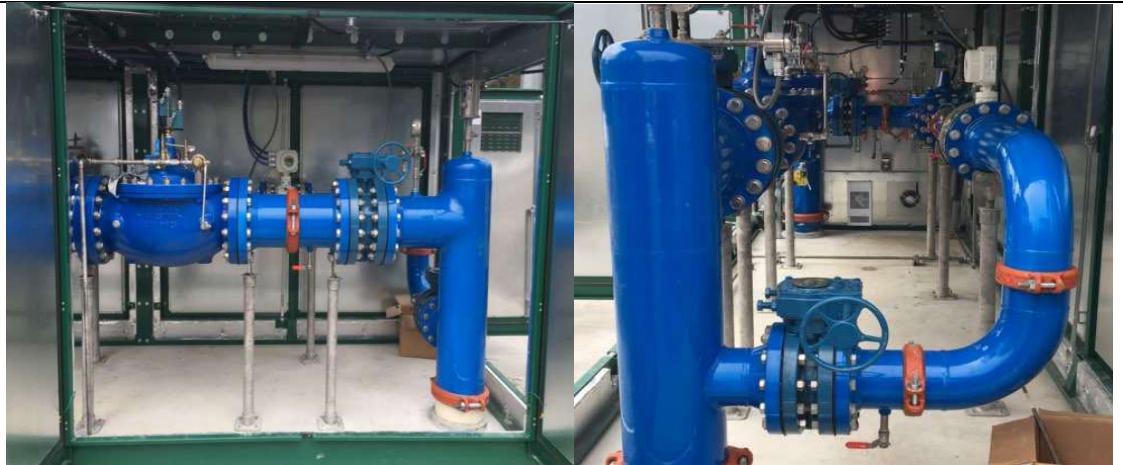
Figure 11: Norum Road PRV Station

Pressure reducing valves are used to step-down pressure in the City's water distribution system to an acceptable supply pressure. The City has 46 pressure reducing valve (PRV) stations containing approximately 85 pressure regulating valves. There are 25 stations connected to the MV water supply system. The remaining 21 are internal to the City's water system. **Figure 11** shows the recently upgraded Norum Road PRV Station.

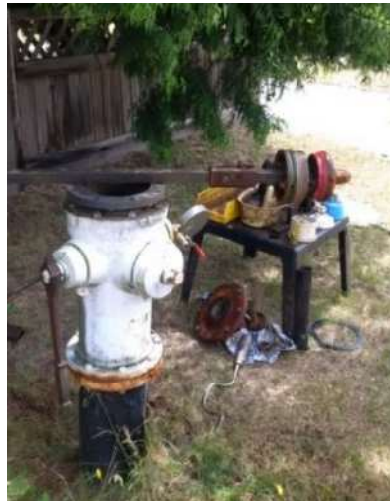
**Figure 12: Fire Hydrant Undergoing Regular Annual Maintenance**

Historically, fire hydrants were only serviced when requested by the Fire Department. To ensure proper fire protection, the City implemented a fire hydrant maintenance program in 1985. The program checks the pressure on each hydrant before it is serviced and dismantled, renewing worn parts as necessary. The hydrant is then lubricated and reassembled. **Figure 12** shows a fire hydrant undergoing regular annual maintenance.

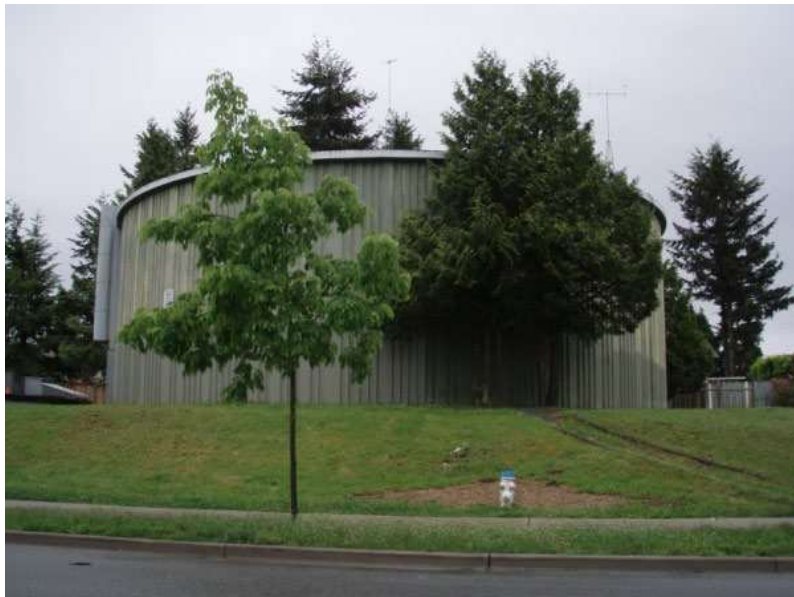
**Figure 13: Hellings Reservoir in North Delta**

The Hellings Reservoir (see **Figure 13**) and Pebble Hill Reservoir are owned and maintained by MV.

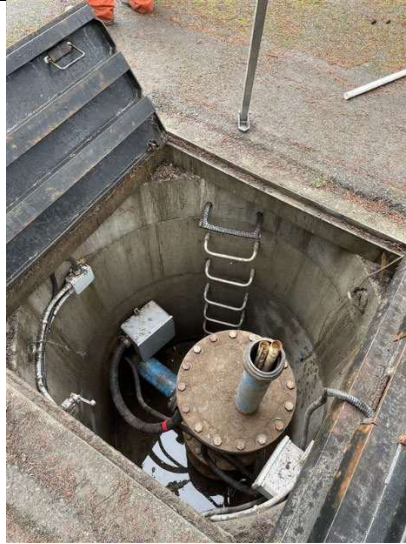
**Figure 14: Well #5, Watershed Park Wells**

The wells are redeveloped every three to five years which involves surging, jetting, and treating the wells with biodegradable product applications. This helps maintain production rates and avoids the costly alternative of replacing a well. All activities in the well field area are closely monitored and regulated.
